# EAGLE CREEK RESORT ASSESSMENT

## ILLINOIS DEPARTMENT OF NATURAL RESOURCES

DNR PROJECT 3-15-006

May 9, 2016

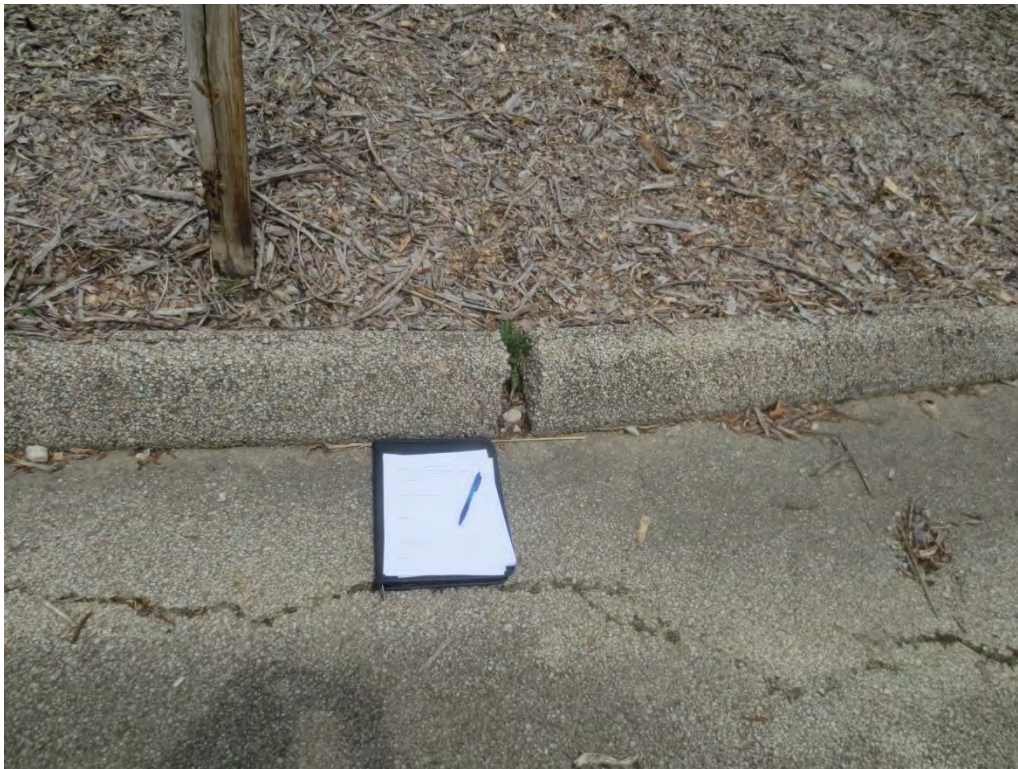
Asphalt curb cracks - typical

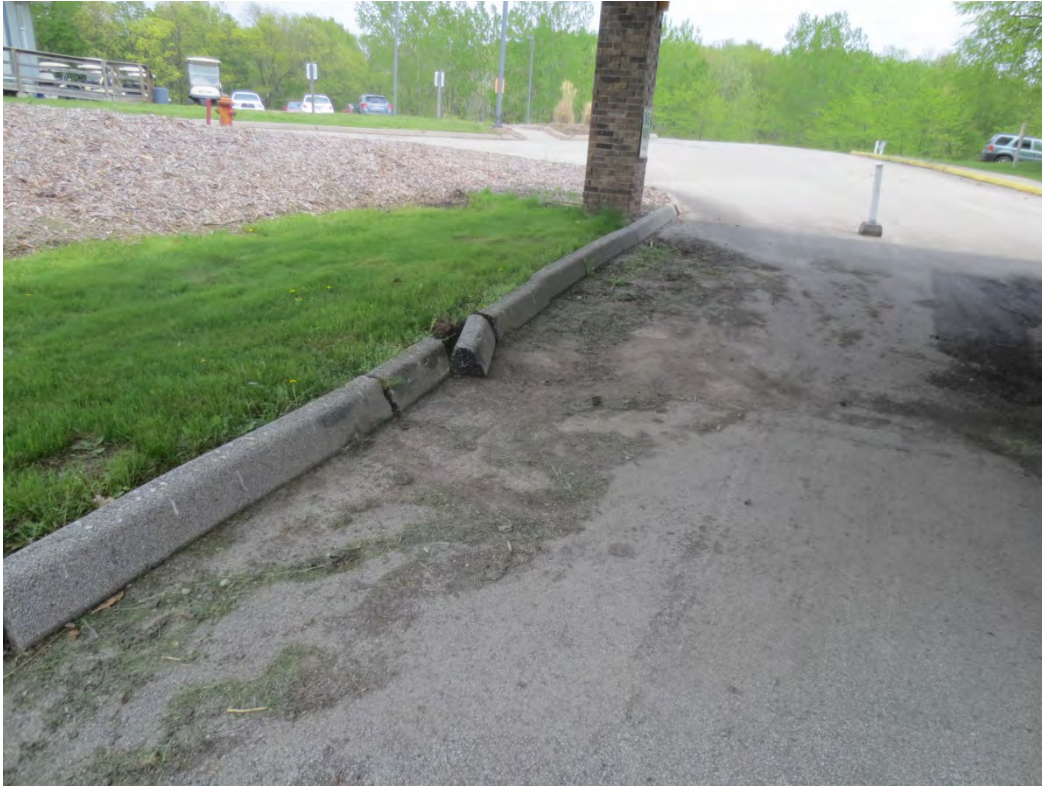
Asphalt curb cracks / displacement at entrance

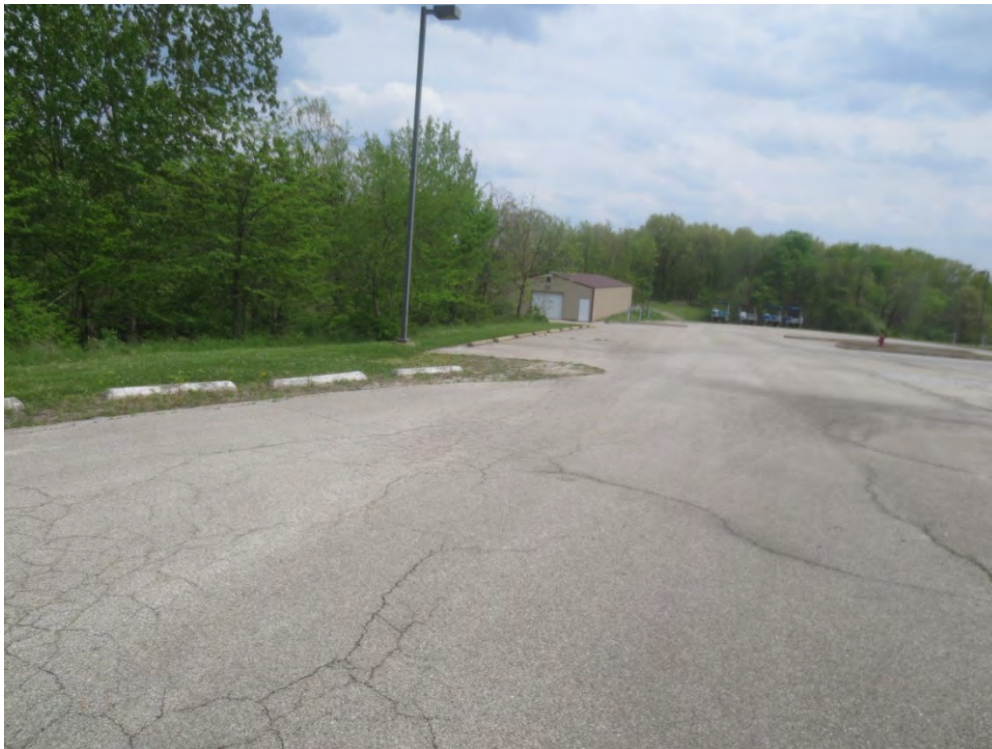
Typical pavement conditions south parking lot

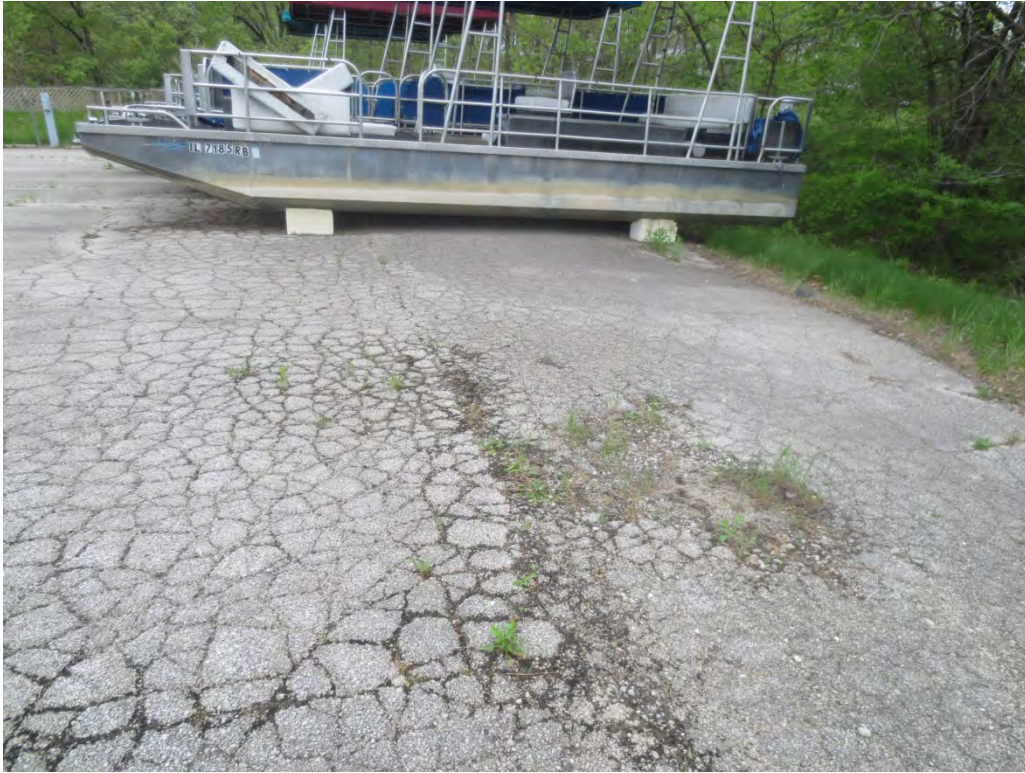
Significant pavement deterioration south end of parking lot

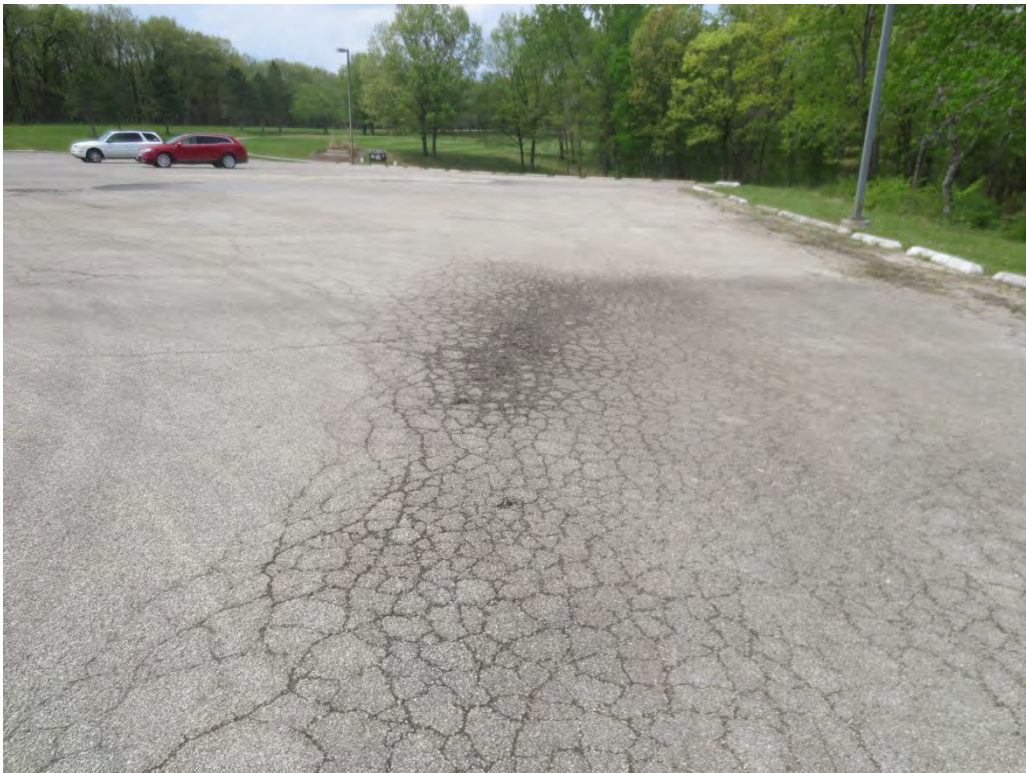
Evidence of localized ponding and pavement deterioration

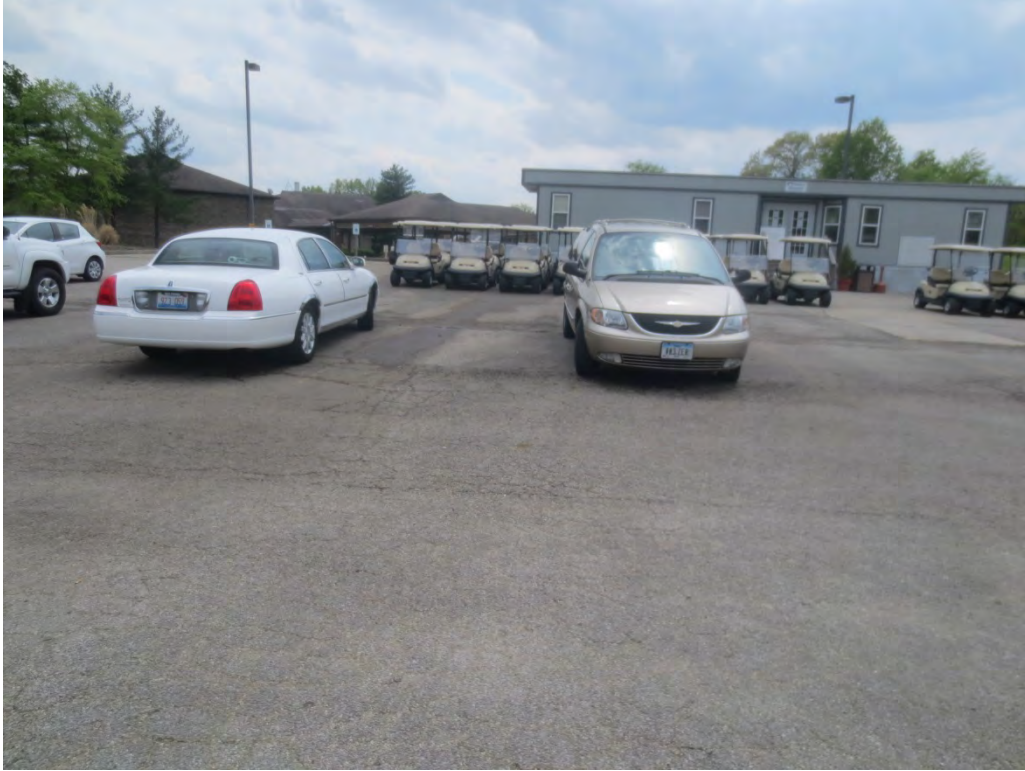
Parking by temporary Pro Shop – two ADA spaces to left of carts, significant alligator cracking

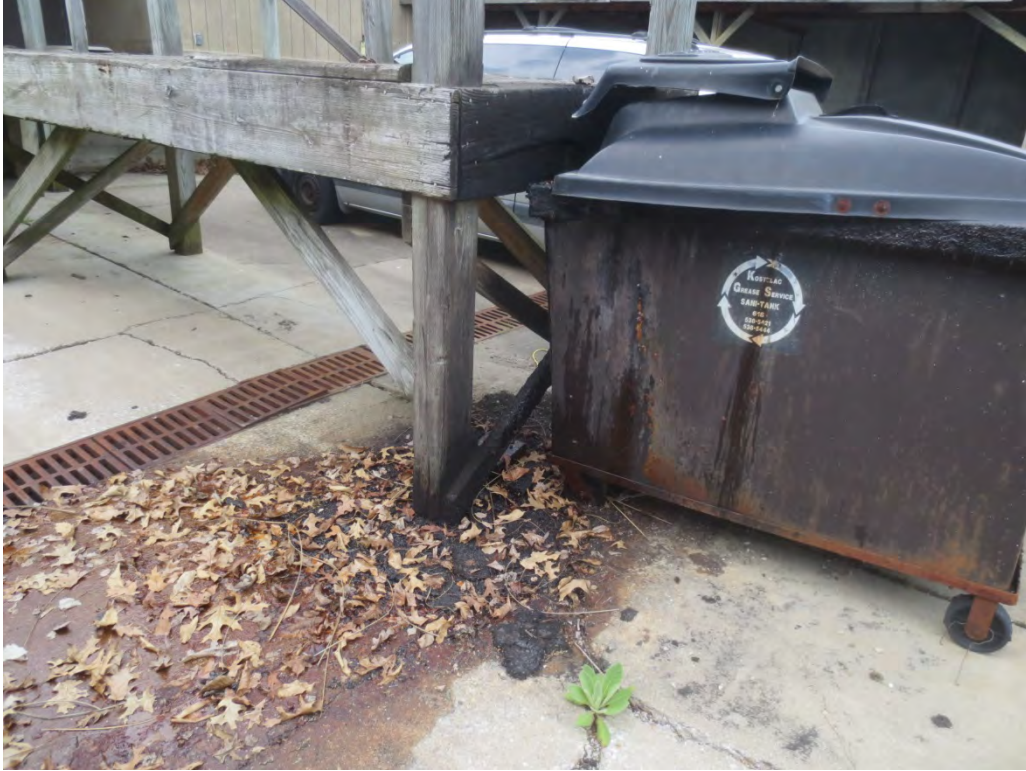
Leaking grease tank draining to storm drain

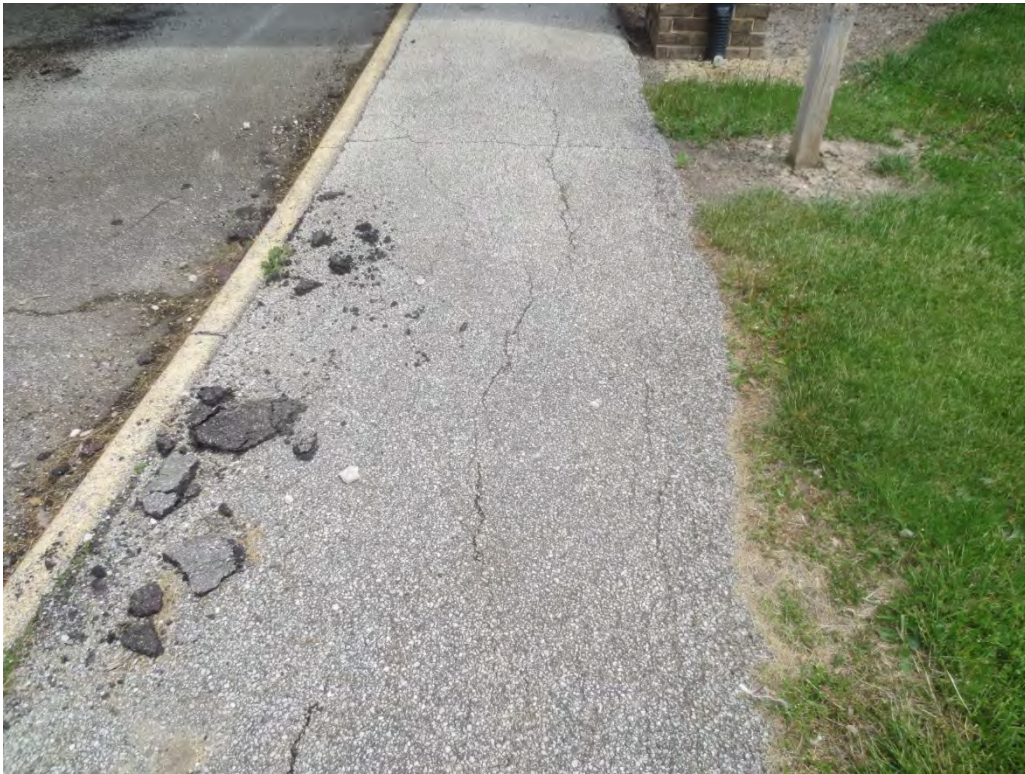
Typical asphalt sidewalk adjacent to roadways; minor cracking; debris is from roadway.

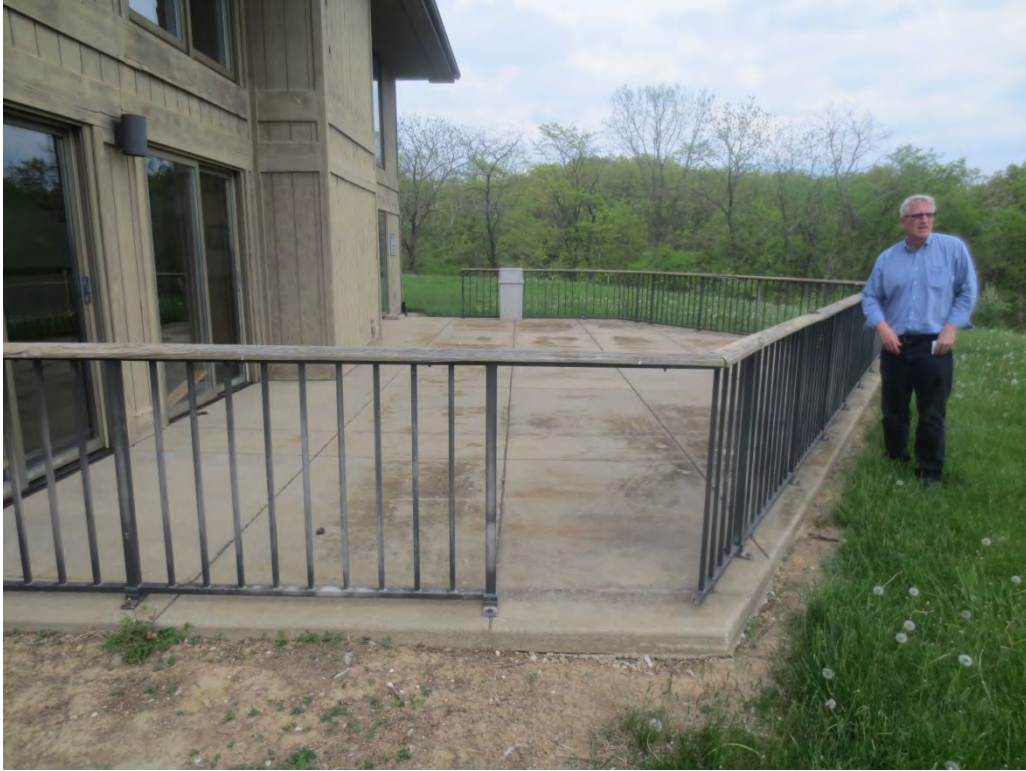
Patio and railing at rear of Eagle's Landing  
(Note missing guardrail)

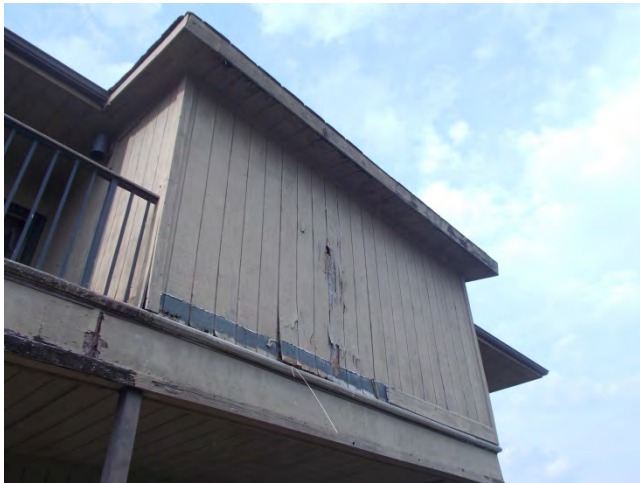
Figure 7 – Typical Wall Deterioration

Wood siding and trim is typically in poor condition throughout. Holes, cracks, and missing trim pieces appear in numerous areas (Figure 7). These deteriorated conditions have been typically left uncovered and therefore have made the wall cavities susceptible to water infiltration. There is some evidence of water damage from inside the walls (Figure 8). Additionally, the removal of thru-wall air conditioner units without properly covering the wall opening has often left the inside of wall cavities exposed and susceptible to water and moisture damage (Figure 9). There is water damage on the wood trim in numerous areas. The original paint finish on the siding and trim has faded and begun to peel over time leaving the bare wood susceptible to further deterioration (Figure 10). Wood trim is also separating from the façade at various locations.

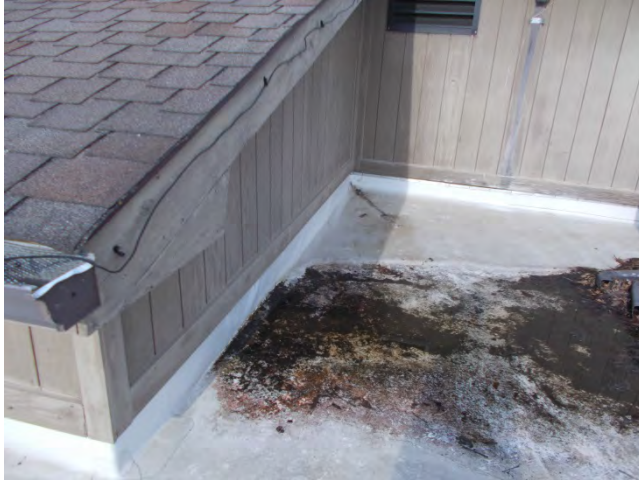
Gutter and downspout system is substantially damaged and is missing pieces throughout. Missing downspouts have caused water to pool and collect in some parts of the flat roof and has caused staining and deterioration to the wood siding, trim, and asphalt shingles (Figures 27 and 28). Some flat roof areas are exhibiting mold.

Figure 27 – Mold at Flat Roof

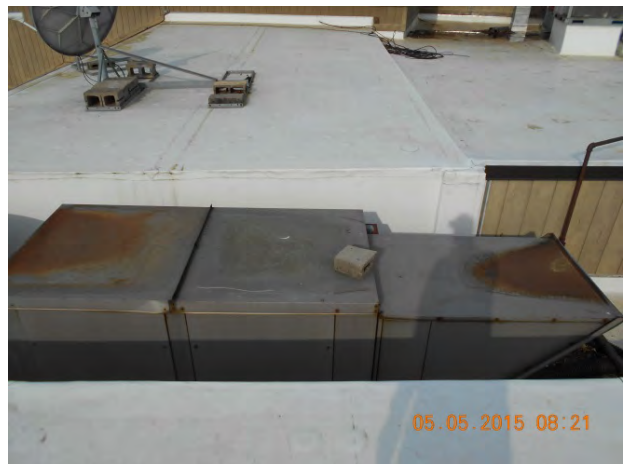
The kitchen and coffee shop makeup air unit appears to be original and is in poor condition. The unit has exceeded its useful service life and is a Class 1 item (Figure 6).

Figure 6 – Kitchen and coffee shop makeup air unit

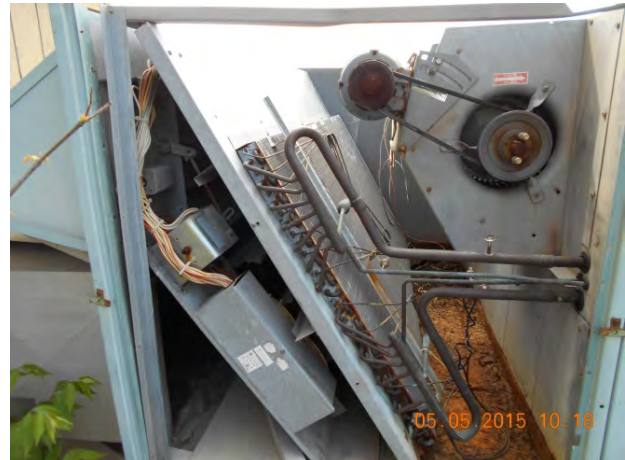
The Eagle's Landing air handling unit appears to be original and is in poor condition. Sections of the housing have been removed exposing interior components to the elements. The unit most likely utilizes the phased out refrigerant R-22, and has exceeded its useful service life. This unit is a Class 1 item (Figure 8).

Figure 8 – Eagle's Landing air handling unit

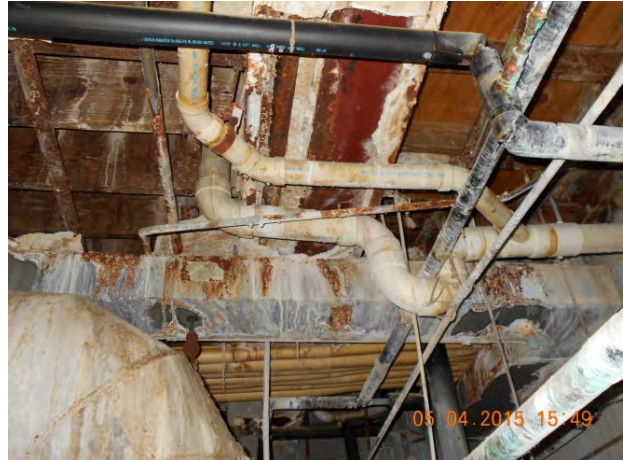
Ductwork appears to be original and in poor to good condition. Interior condition of ductwork was not observed. These are Class 2 and Class 3 items (Figure 10).

Figure 10 – Mechanical room ductwork corrosion

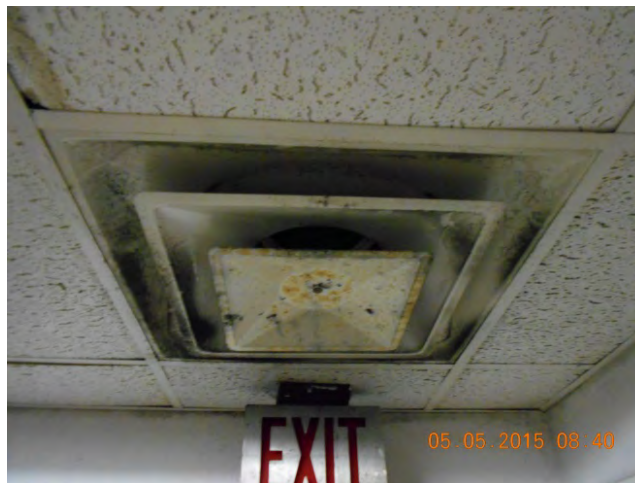
Observed diffusers, grilles and registers appear to be original and in poor to good condition. These are Class 1 and Class 3 items (Figure 11).

Figure 11 – Supply diffuser mold

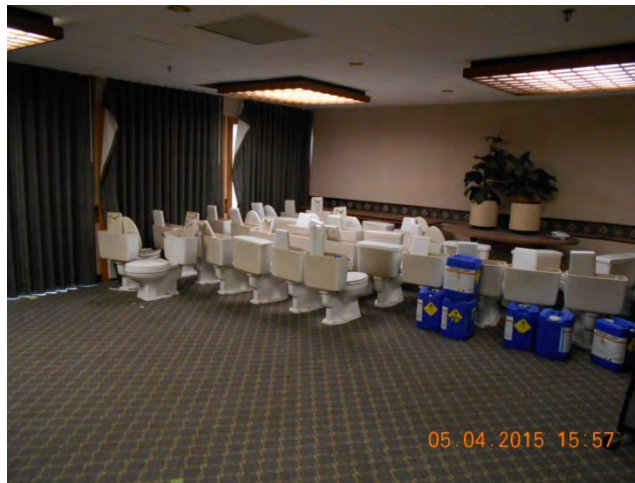
Observed plumbing fixtures include commercial, residential and kitchen. The majority of guest room plumbing fixtures have been removed. Toilet fixtures are openly stored at various locations inside the building (Figure 1).

Figure 1 – Water closets stored in open space

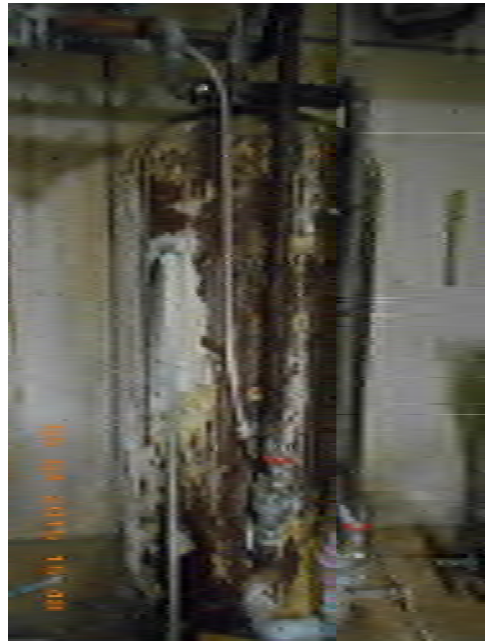
The domestic water surge tank appears to be original and is in poor condition with heavy corrosion (Figure 3). This is a Class 1 item.

Figure 3 – Domestic water surge tanks

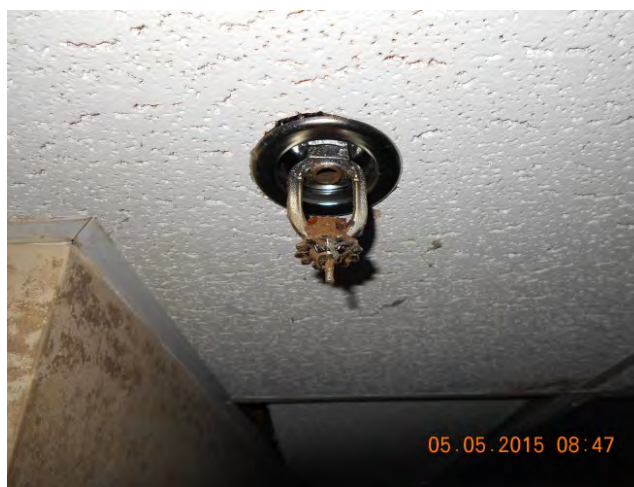
Building sprinkler heads are a combination of exposed pendent type, recessed, exposed, sidewall and upright depending on room architecture. All sprinkler head fuses have been removed (Figure 5).

Figure 5 – Sprinkler head with fuse removed located in main hotel

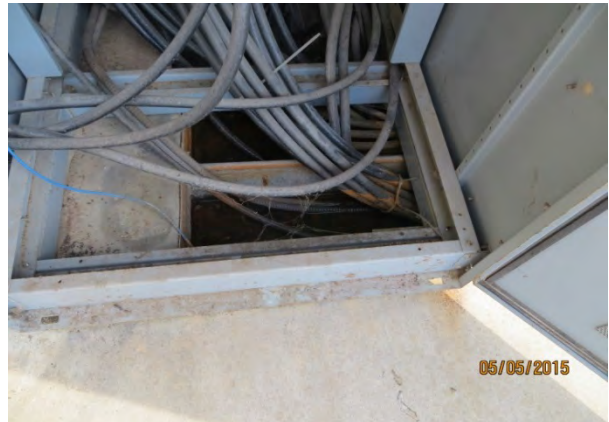
The load side of ATS is connected to the 2500 Amps 277/480 volts, 3 phases, 4 wires Service Switchboard, which is located in basement in the Electrical Room (Figure 5). The feeder cables are in concrete encased conduits from the ATS to the switchboard. These conduits are also filled with water and water can be seen in the conduit space below the switchboard (Figure 6). In addition, there is 4 inches of corrosion along the perimeter of the switchboard providing evidence that water has infiltrated the switchboard via the conduit system.

Figure 6 – 2500 amp, 277/480VAC main switchboard with submerged service feeders
