# EAGLE CREEK RESORT ASSESSMENT

## ILLINOIS DEPARTMENT OF NATURAL RESOURCES

DNR PROJECT 3-15-006

May 9, 2016

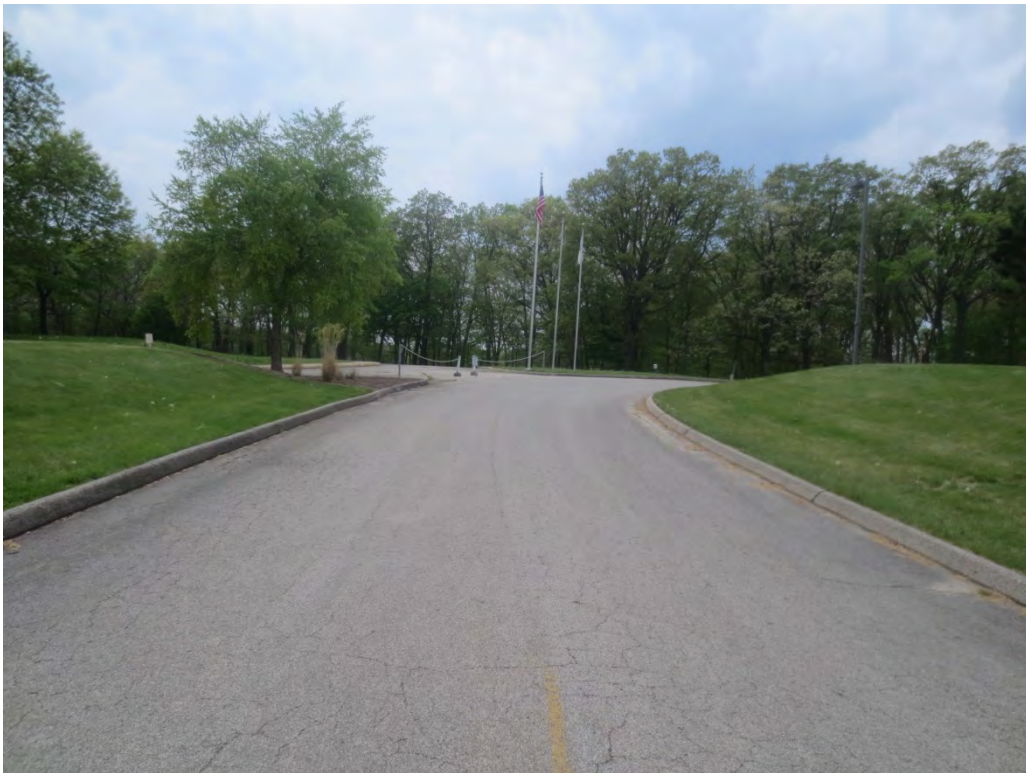
- General pavement showed some cracking that should be sealed at a minimum.
- Pavement in main hotel drop off area under the canopy had significant cracking / potholes, evidence of prior repairs and needs to be replaced.
- Drainage appeared good. One inlet structure on north side of roadway closest to hotel appeared to be in good condition. Storm sewer leads west to the lake. Manholes were clean and in good condition.
- Asphalt curbs were in fair to poor condition – needs repairs / sealing. Some displaced sections of curb need replacement.
- Signage was faded and needs replacement.
- Adjacent asphalt sidewalk in fair to good condition. Some cracks in need of sealing.
- Appears to be two water lines running at the surface crossing the exit road to the temporary Pro Shop trailer.
- Exit roadway appears in good condition – needs resealing / alligator crack repairs.

Exit Road

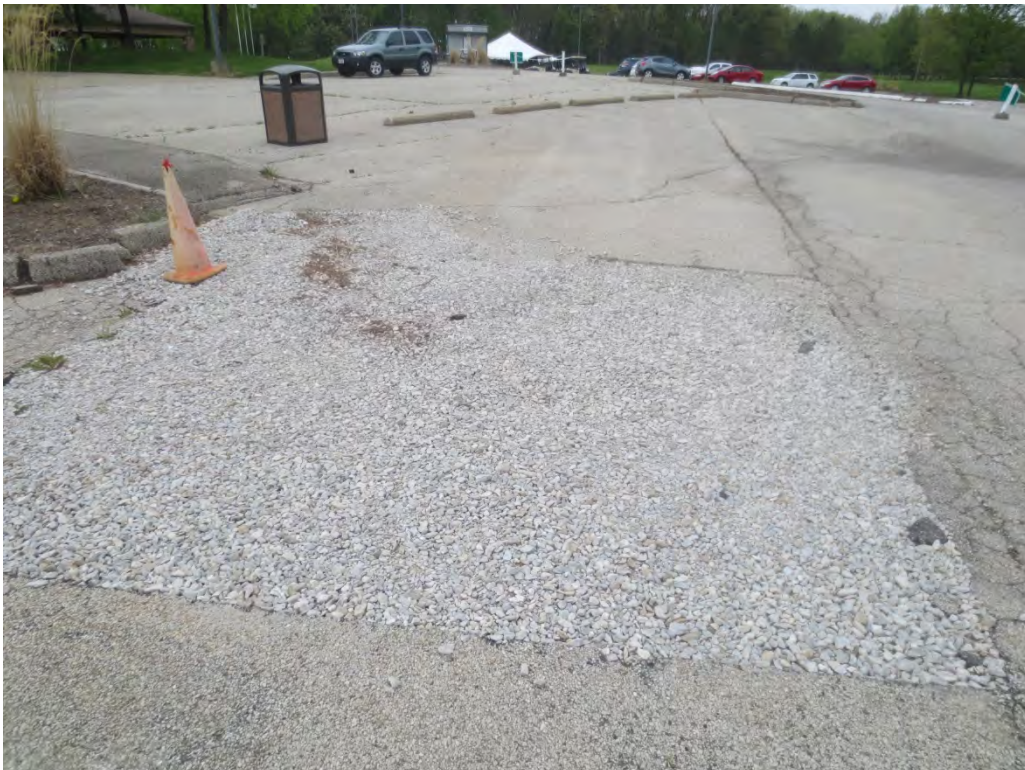
Approximately 15' x 15' area of gravel near loading dock

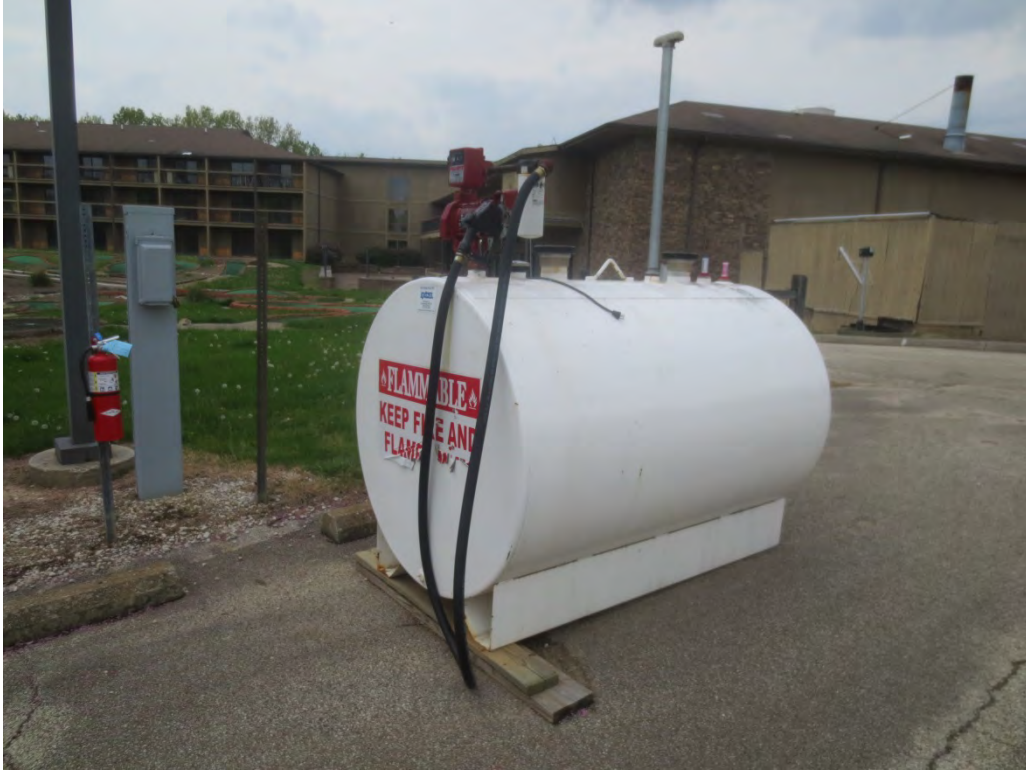
Unprotected fuel tank adjacent to mini-golf

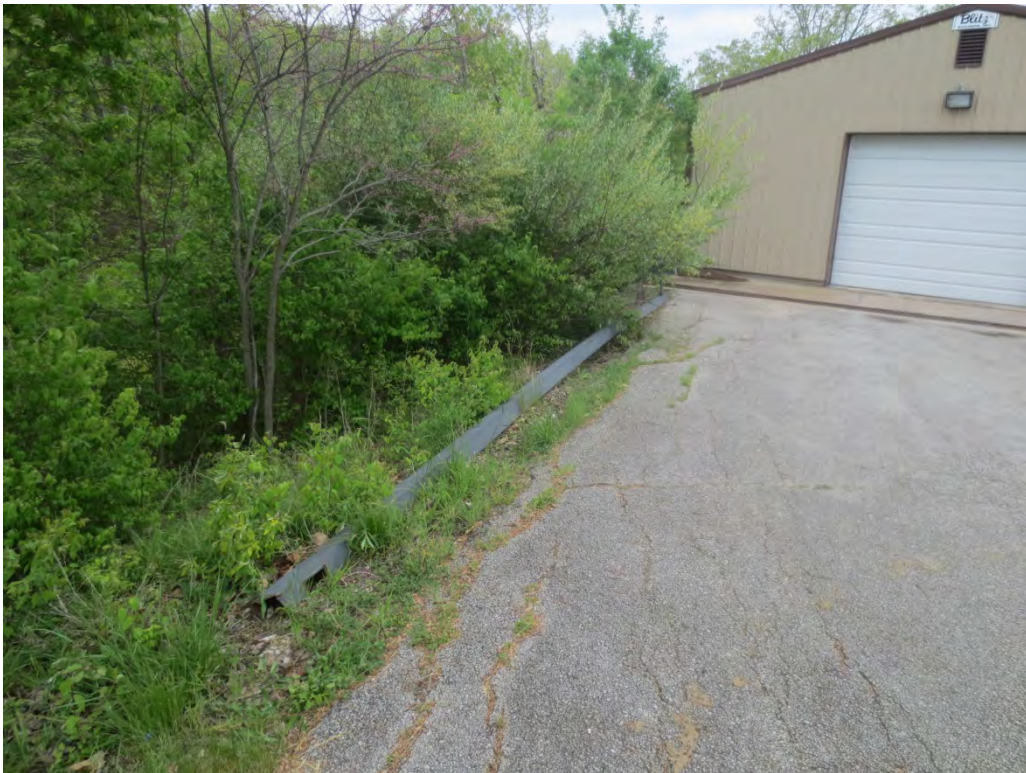
Steep drop off north of cart building

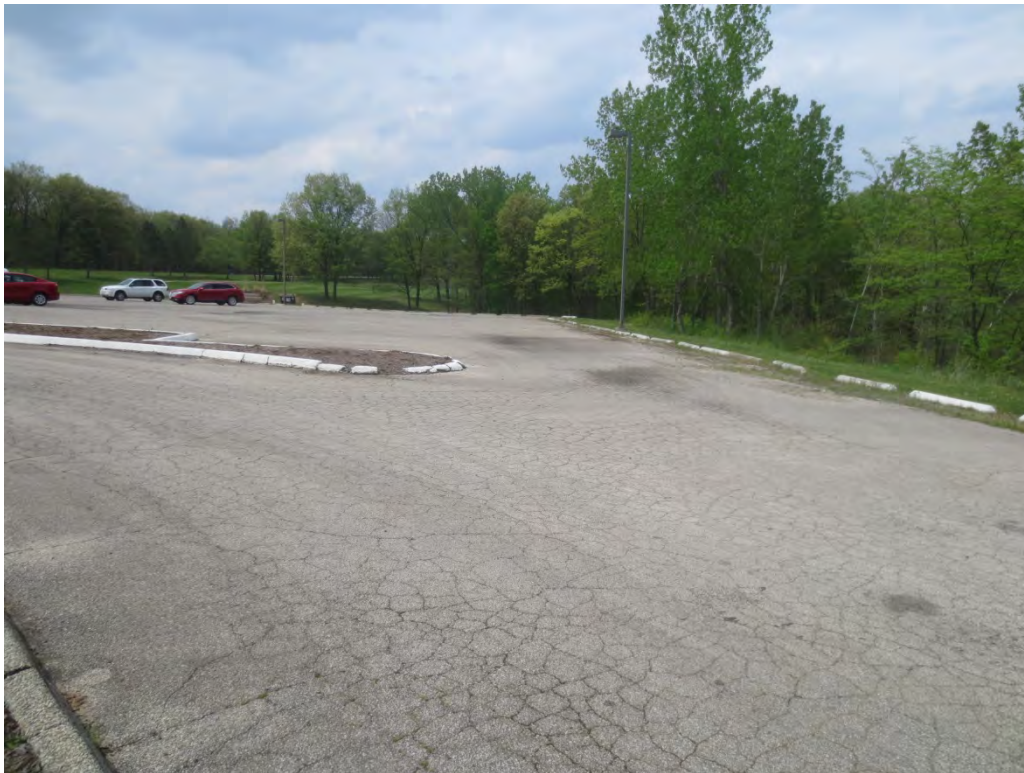
- Appears to be used primarily for vehicle parking. Currently also includes golf cart parking, tent and trailer for golf course temporary pro shop.
- Alligator cracks throughout with some minor rutting – repave with bituminous asphalt paving.
- Asphalt curbs cracked and in fair to poor condition.
- Parking space striping significantly faded to non-existent.
- Wheel stops in generally good condition; located in grass in some areas.
- Two ADA spaces marked near trailer. Signage appears to be more recent.
- Drainage is generally fair to good. Drains by sheet flow. Pavement slope is flatter than in south lot. A few areas appear to pond water. No inlets / catch basins.
- Several traffic islands have been removed and paved over. These are typically used to help control traffic flow in parking lots. These should be replaced.

Typical pavement - north parking lot area pavement

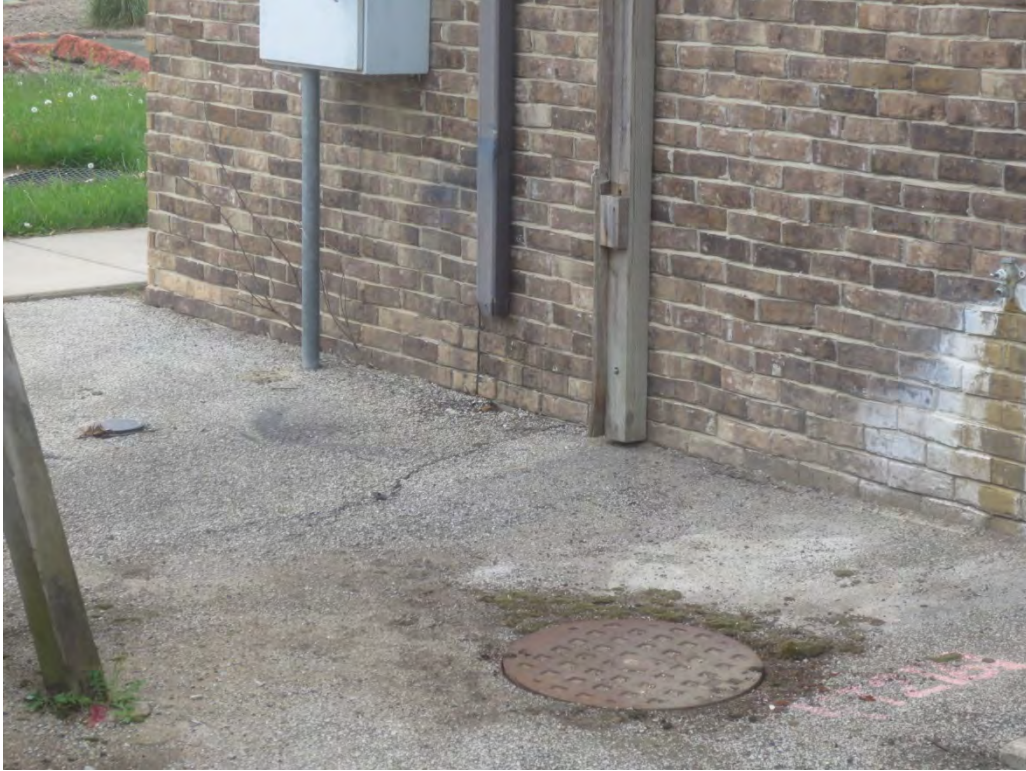
Roof drain discharging to pavement

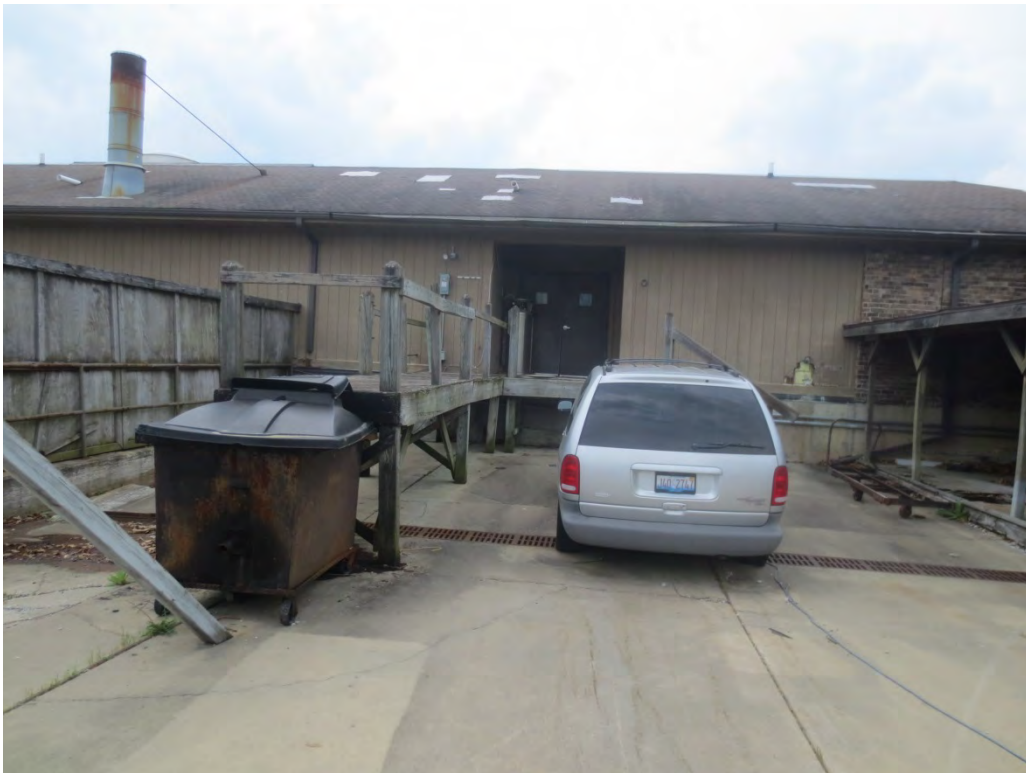
- Concrete pavement in the loading dock area is in fair condition.
- There is a missing grate on the stormwater slot drain.
- The wooden loading dock and wood fencing in this area are in poor condition and should be reconstructed during the renovation phase.

Loading dock area; note wooden dock platform

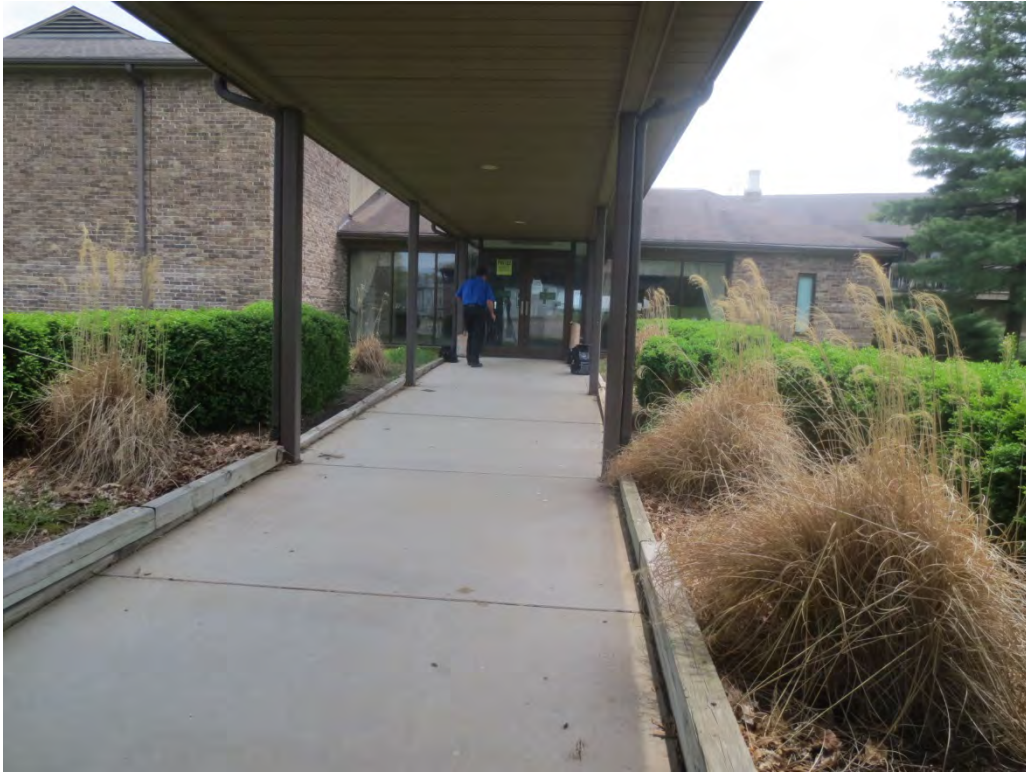
Main entry concrete walk

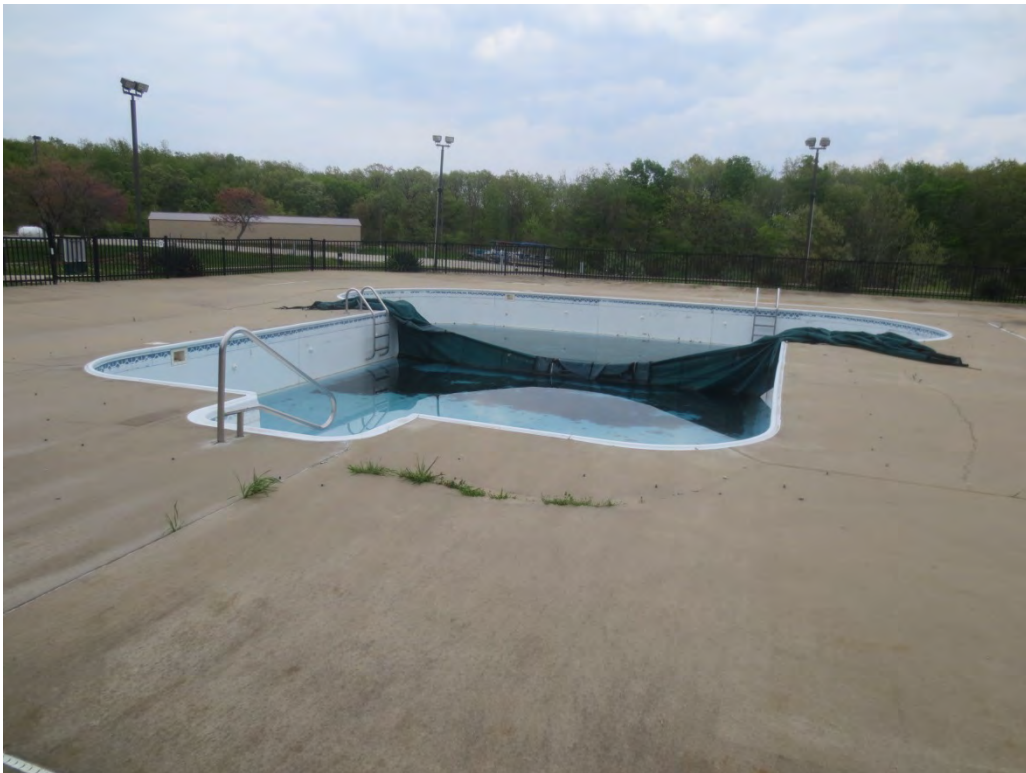
Pool Area concrete

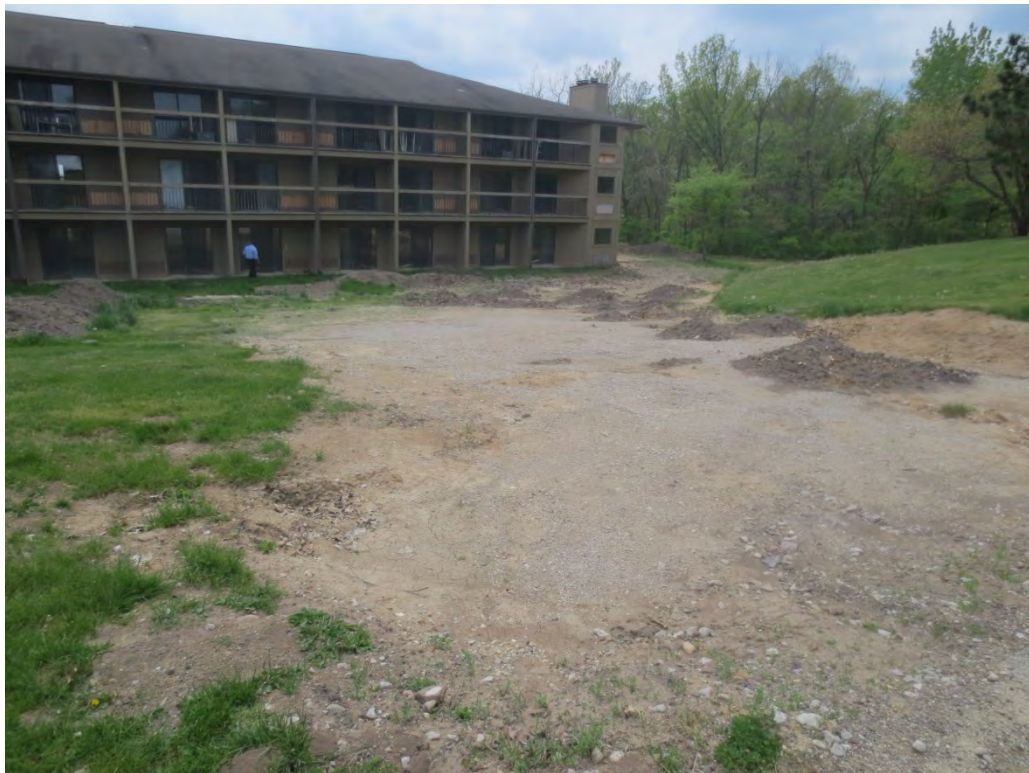
Disturbed landscape area near front of hotel

- Some bare patches of turf area were noticed throughout the site. These can be remedied with minor topsoil placement and seeding.
- There were few trees or shrubbery in the immediate hotel area. Additional site landscaping should be performed to improve the overall aesthetic quality of the site.

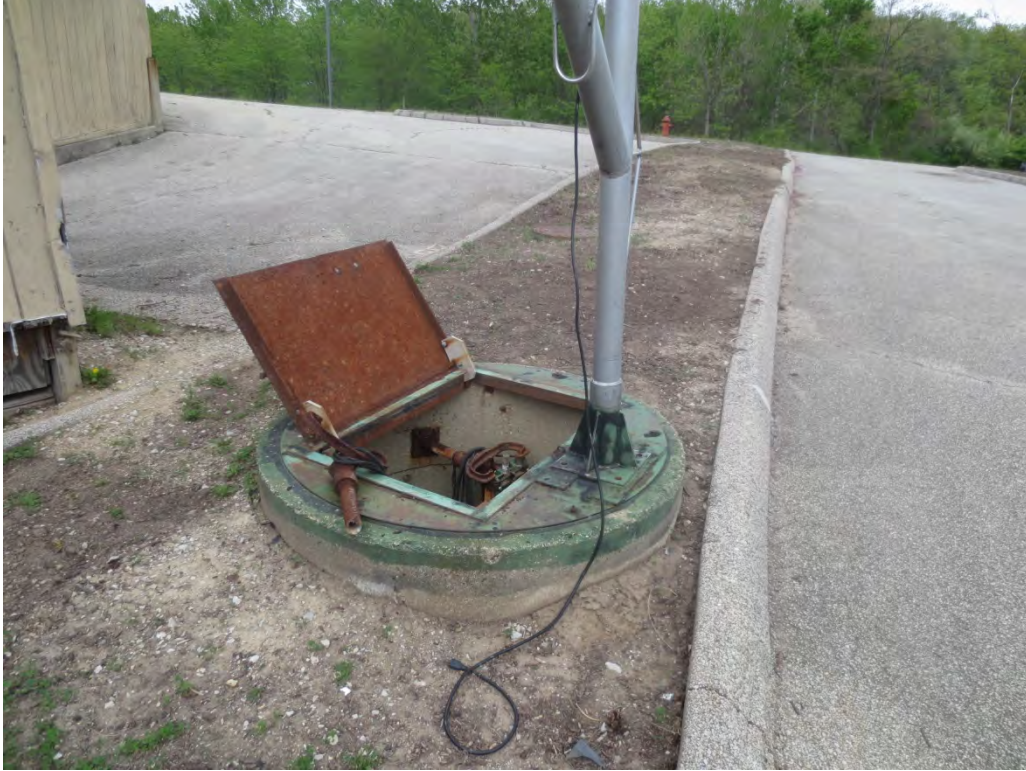
- The force mains were tested on March 17 and 18, 2016. Due to the unreliability of the pumps, the force mains were temporarily connected to the fire main water supply and flushed. A flow test was conducted by flushing the forcemains with water. The hydrant pressure was sufficient to flush out both lines. Water was observed entering the Berry Pond pump station. A pressure test was conducted by installing a pressure gage on the line from the fire hydrant to the force main. The force mains held pressure at 30 PSI for two hours without loss of pressure or evidence of leakage.

- Based on the flow and pressure test, the force mains appear to be in working condition. It is likely that there was some accumulation of solids in the line over time which may have impeded flow at some point. If the force main system is put back in service, recommend periodic flushing of the line to remove solids accumulation. Heavy duty grinder pumps made specifically for sanitary force main systems should be used, particularly with the increased use of "flushable" wipes — a known clogging issue in sanitary sewer systems. Addition of inspection / clean out ports on the force main system is not recommended due to the potential increase in failure points in the system at the junctions. Replacement of the force main is not recommended.

Sanitary Sewage Pump Station near dock area

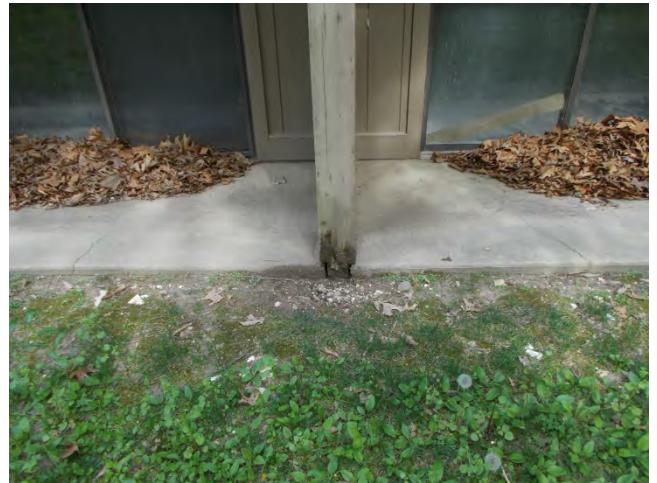
Wood siding and trim is typically in poor condition throughout. Holes, cracks, and missing trim pieces appear in numerous areas (Figure 7). These deteriorated conditions have been typically left uncovered and therefore have made the wall cavities susceptible to water infiltration. There is some evidence of water damage from inside the walls (Figure 8). Additionally, the removal of thru-wall air conditioner units without properly covering the wall opening has often left the inside of wall cavities exposed and susceptible to water and moisture damage (Figure 9). There is water damage on the wood trim in numerous areas. The original paint finish on the siding and trim has faded and begun to peel over time leaving the bare wood susceptible to further deterioration (Figure 10). Wood trim is also separating from the façade at various locations.

Figure 8 – Wood Party Wall at Grade

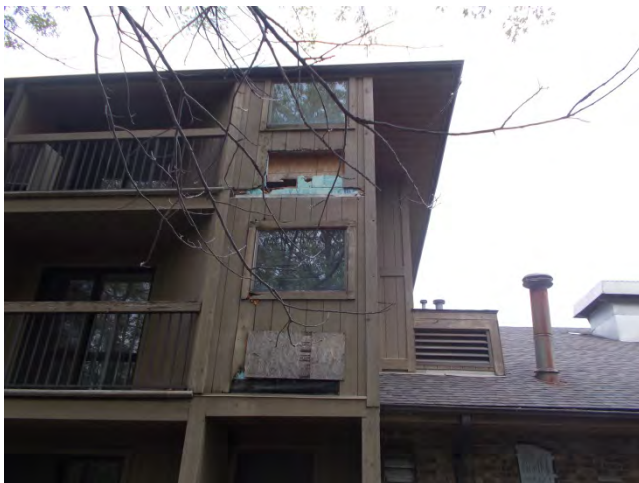
Figure 9 – Exposed A/C Openings in Wall

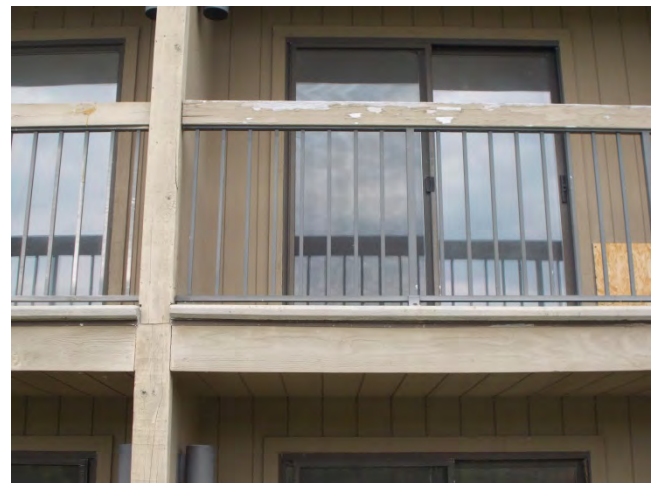
Figure 10 – Balcony

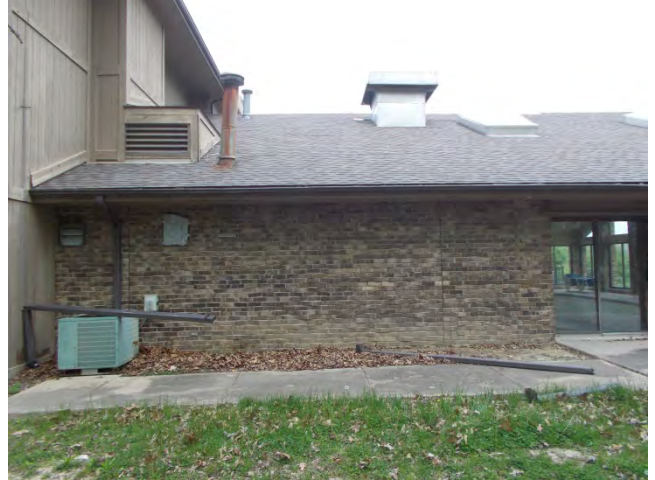
Missing or damaged downspouts and splash blocks have created conditions where water has not been shedding properly away from the building and has likely caused roof/foundation damage due to erosion (Figures 15 and 16).

Figure 16 – Hotel Entrance Wall

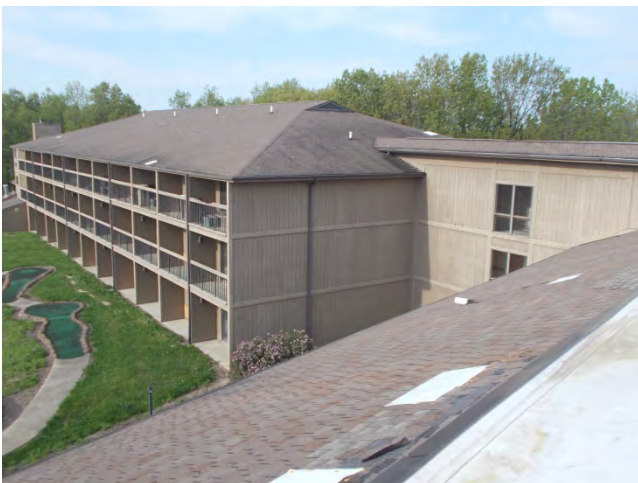
Figure 17 – Shingled Roof  
(Note Roof Patches)

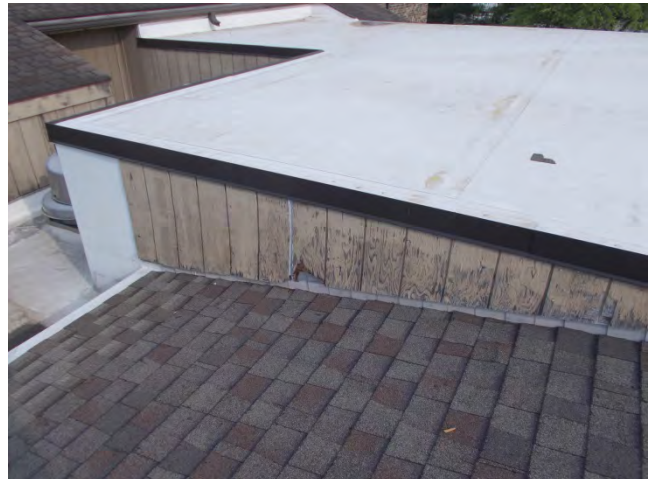
Figure 22 – Various Roof Conditions

There are typically sheet metal gutters with downspouts installed at roof eaves. The flat portion of the roof has internal roof drains. Aluminum flashing and cant strips are installed at the edges of flat roof portions (Figure 22).

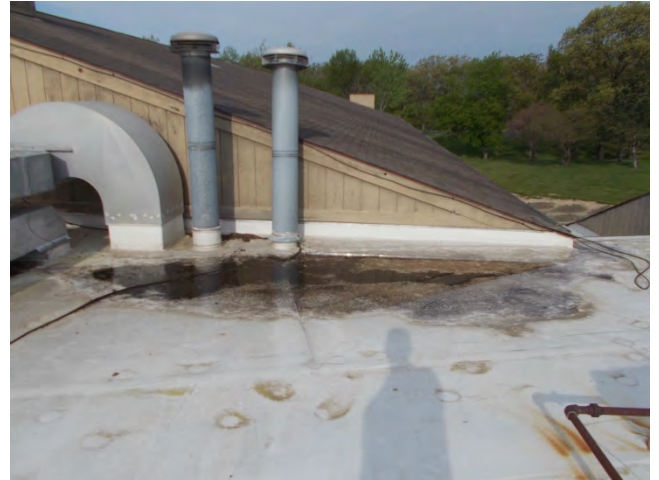
Gutter and downspout system is substantially damaged and is missing pieces throughout. Missing downspouts have caused water to pool and collect in some parts of the flat roof and has caused staining and deterioration to the wood siding, trim, and asphalt shingles (Figures 27 and 28). Some flat roof areas are exhibiting mold.

Figure 28 – Ponding at Flat Roof

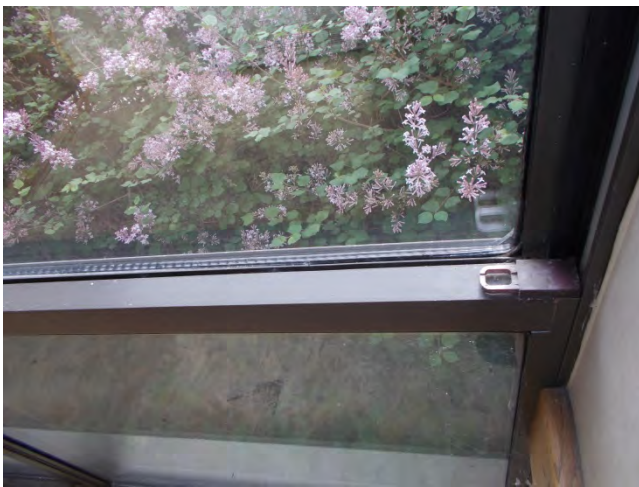
Window systems all appears to be original to the building. There does not appear to be significant damage to the windows however windows of this age would not be as energy efficient as windows of current technology. General deterioration of weather-seals and gaskets has occurred over time. There are some damaged/missing louvers, as well.

Figure 31 – Double-Hung Window

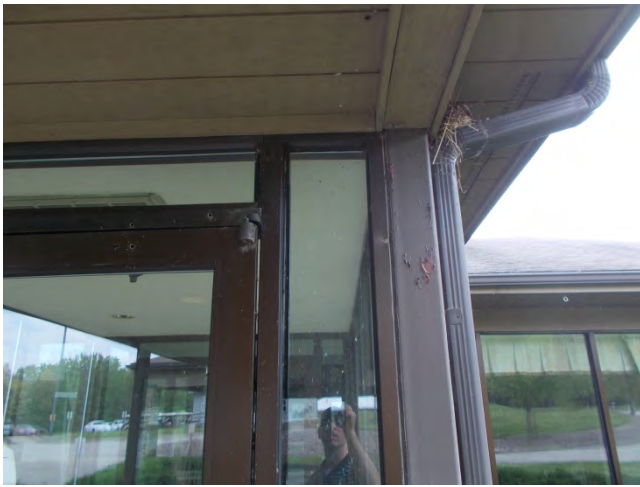
Exterior doors appear to all be original to the building. No significant damage appears to have occurred; however, due to age, general wear, and a long period of disuse most hardware is in fair to poor condition and some hardware is missing completely (Figures 37 and 38). Hollow metal doors and frames have instances of rusting and peeling paint particularly at the base and are in fair to poor condition due to age and wear (Figure 39). Wood framed sliding glass doors are in poor condition due to frame cracking and peeling along the frames (Figure 40). General deterioration of weather-seals and gaskets has occurred over time as well. Exterior hollow metal doors within the kitchen area are in very poor condition likely due to heavy usage and missing weather seal hardware.

Figure 37 – Exterior Door Detail

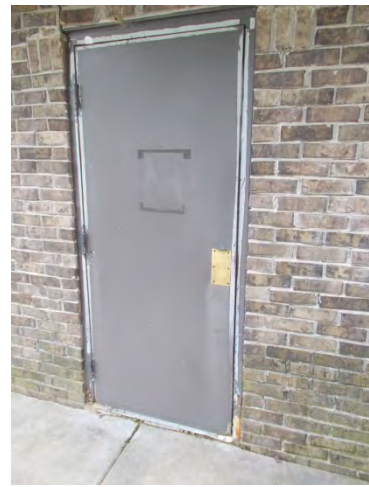
Figure 38 – Hollow-Metal Door without Hardware

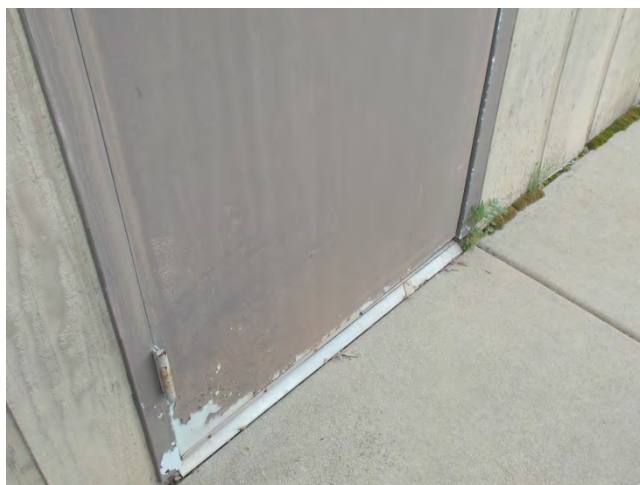
Figure 39 – Hollow-Metal Door

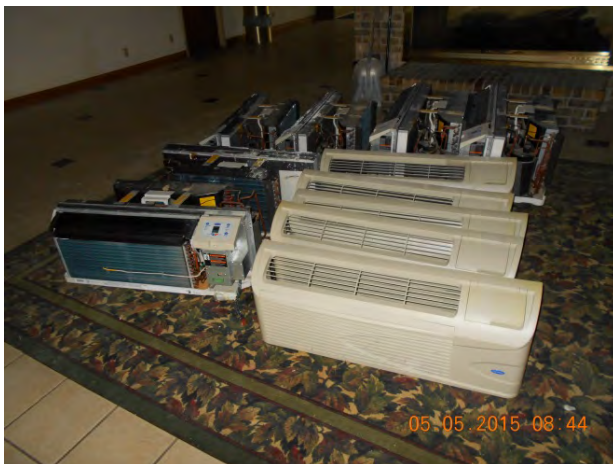
Hotel wing guest rooms are served by individual wall mounted PTAC units with 1 ton cooling capacity and 3.7 kw electric heating capacity. Numerous PTAC units have been removed and are being stored in various locations inside the building, as well as on exterior balconies (Figures 1 and 2). For each wing toilet exhaust risers are provided for each back to back guest room tier and tied into a common exhaust header in the attic and discharged to the outside by a 2200 cfm inline ceiling hung exhaust fan. In addition, each attic space is provided with a 2200 cfm inline ceiling hung exhaust fan.

Figure 1 – PTAC units stored in open space

Recommendation is to replace all PTAC units.

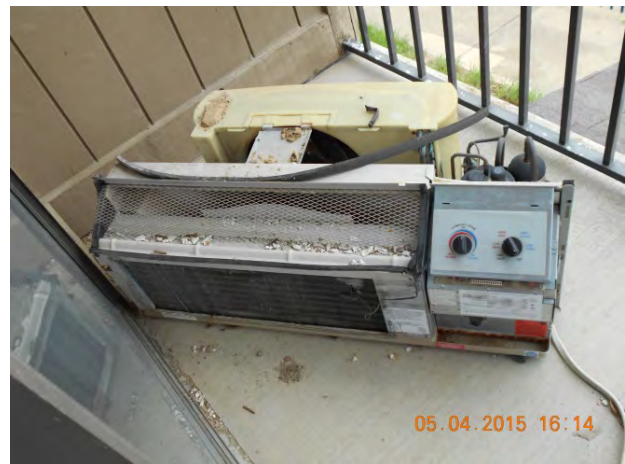
Figure 2 – Guestroom PTAC unit stored on balcony

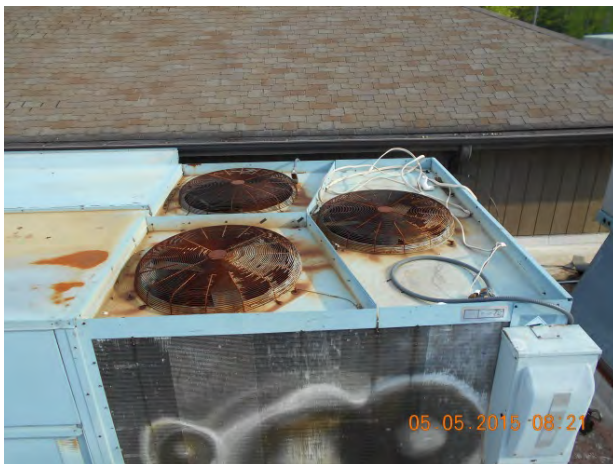
The restaurant and bar/lounge rooftop unit appears to be original and is in poor condition with heavy evaporator fin damage. The unit has exceeded its useful service life. This unit is a Class 1 item (Figure 5).

Figure 5 – Restaurant and bar/lounge mechanical rooftop unit

Recommendation is to replace the rooftop unit with a new unit compliant with 2016 IECC.

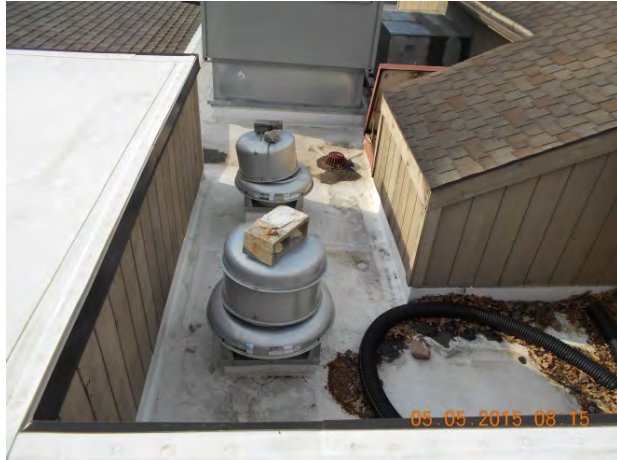
Exhaust fans appear to be original and in poor to fair condition. Guest room and attic fans were not observable. These appear to be Class 1 and Class 3 items (Figure 9).

Figure 9 – Rooftop exhaust fans

Recommendation is to test all exhaust fans for proper operation and repair or replace as needed.

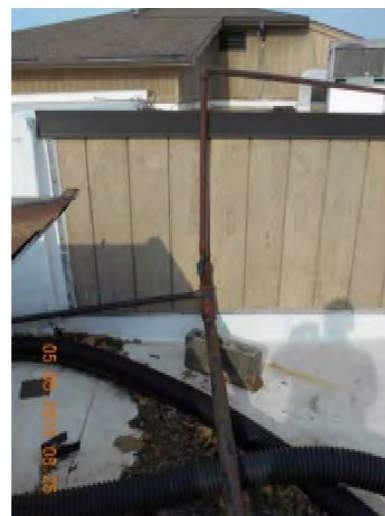
Observed black iron gas distribution piping appears to be original and is in poor to good condition with some piping having varying degrees of rust. These are class 1 and 3 items. Recommendation is to provide a pressure leak test. Brush off surface rust and replace piping sections that are heavily corroded with rust (Figure 13).

Figure 13 – Gas pipe routing to rooftop mechanical units

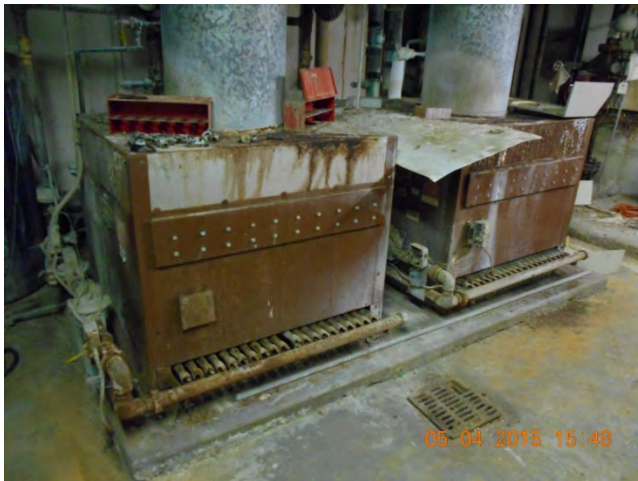
The main hotel and conference center domestic hot water boilers appear to be original and in poor condition (Figure 2). The burners and gas train assembly are heavily rusted. The Eagle's Landing electric domestic water boiler appears to be in good condition. The main resort domestic hot water boilers have exceeded their useful service life and are class 1 items. The Eagle's Landing electric boiler is a Class 3 item.

Figure 2 – Hot water boilers

The recommendation is to replace the main resort building domestic water boilers with Department of Energy efficiency compliant condensing boilers sized to meet new building demand loads. Provide an operation and performance test on the Eagle's Landing boiler.

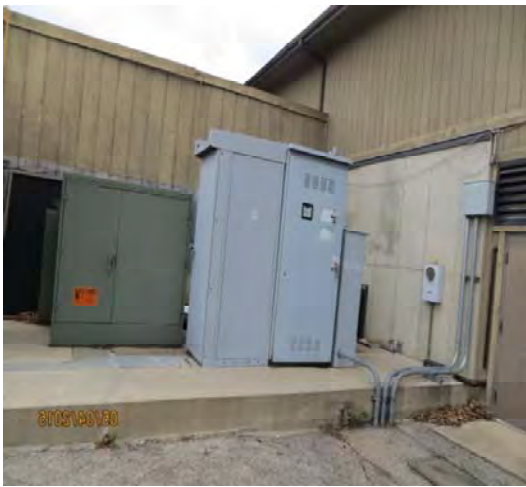
The facility is fed by two electrical services. The first source is the existing utility transformer (Figure 1) and the second is a 750KW, 277/480 volt, 3 phase 4 wire emergency generator (Figure 2). Both services are connected to an existing 2500 Amps, 277/480 volts, 3 phase, 4 wires Automatic Transfer Switch (ATS) (Figure 1). The service feeder cables from the utility transformer and the generator are run via a cable trench and connected to the normal and emergency sides of the ATS respectively. The cable trench is filled with water and the services cables are submerged.

Figure 1 – Utility transformer and automatic transfer switch

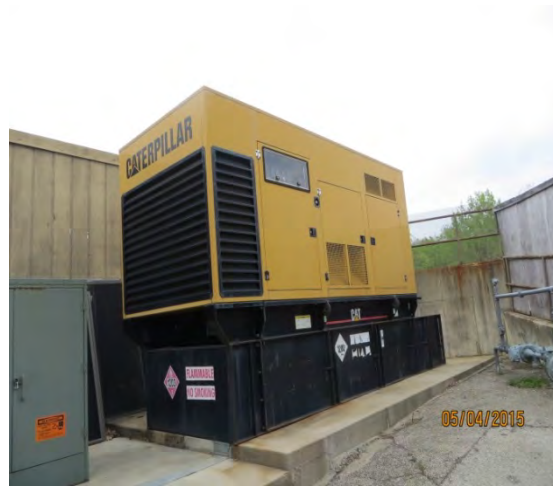
Figure 2 - 750kW Diesel Generator

Based on review of the original electrical design plans it was determined that the existing ATS and generator were added at some point after the original construction. The generator appears to be in relatively good condition based on visual inspection. The generator has sat idle for a number of years. Some of the replacement parts had the year 2012 hand written on them, which would indicate that the generator has not been serviced recently. Finally, there was an audible alarm going off during the site visit.

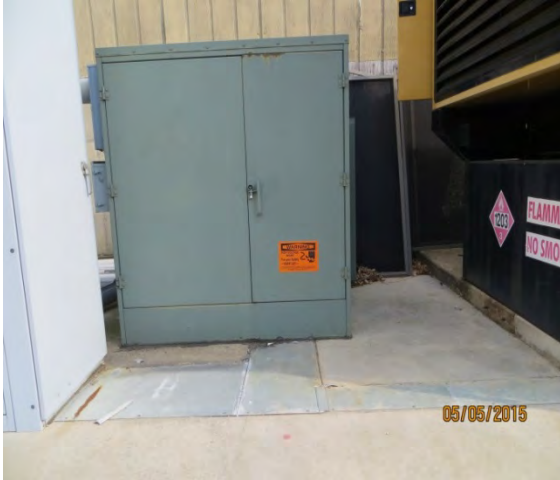
The service cables from the generator and the utility transformer run through a metal trench with a cover (Figure 3). The gasket/caulking has failed and the feeder cables are submerged in water. Water can also be seen in the conduit space of the ATS (Figure 4).

Figure 3 – Metal trench with service feeder cables

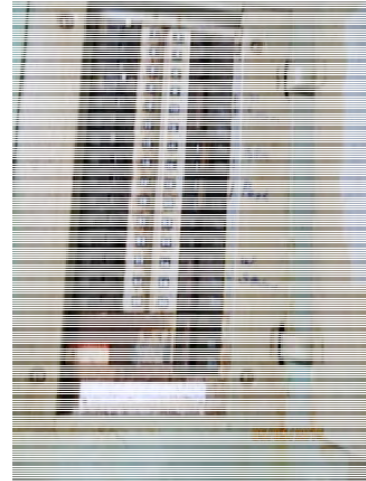
The electrical panels serving the inside swimming pool are corroded. All electrical equipment including conduit and wires in this area should be replaced. Electrical equipment subject to this environment should be rated NEMA 4X. Refer to the Pool Section of this report for additional details (Figures 9 and 10).

Figure 10 – Indoor swimming pool panelboard interior

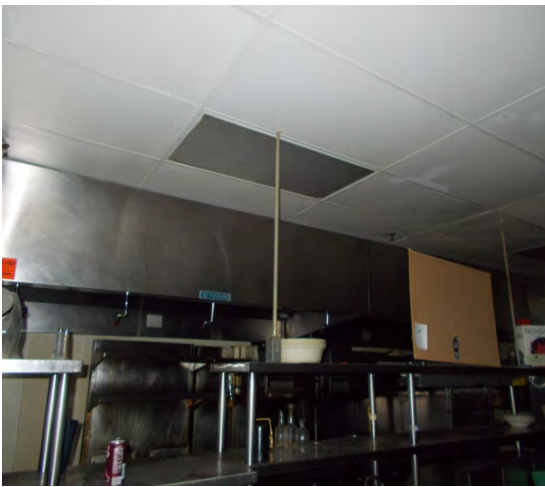
Figure 29 – Kitchen food prep lighting

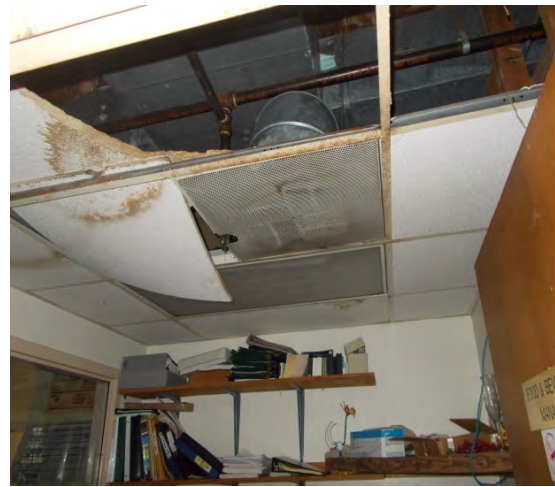
Figure 30 – Kitchen office lighting

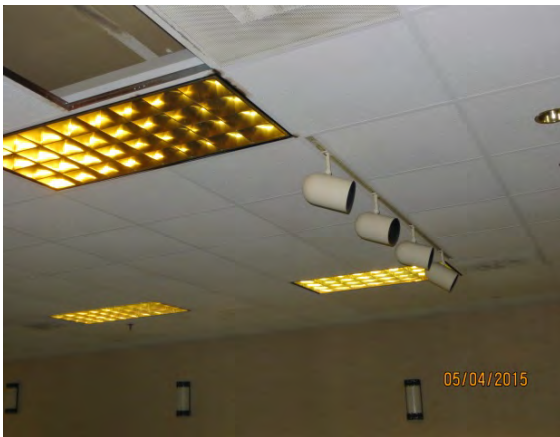
Figure 31 – Lounge area lighting

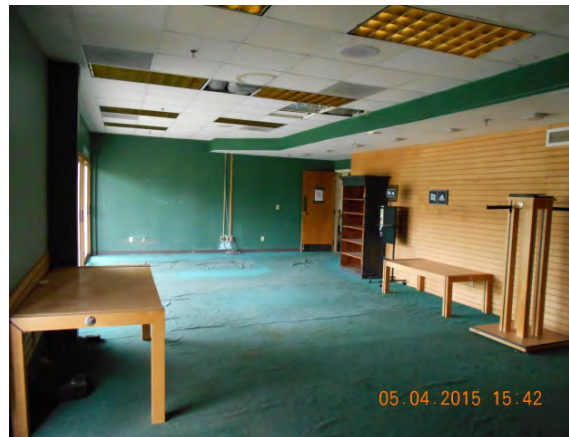
Figure 32 – Recreation area lighting

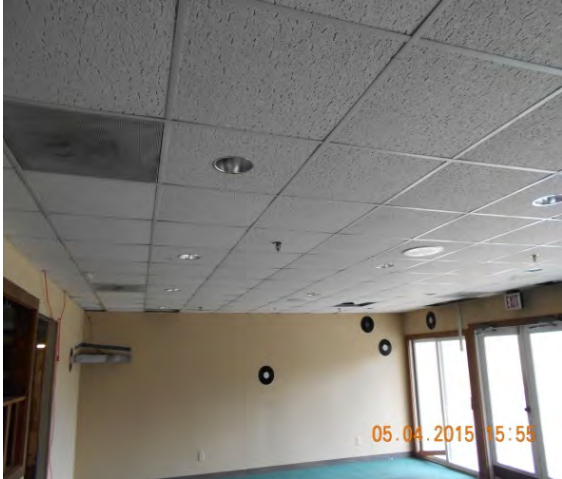
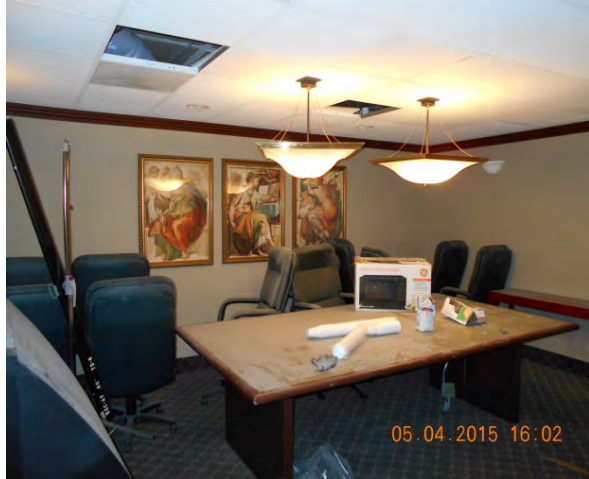
Figure 33 – Meeting room lighting

Figure 34 – Meeting room lighting

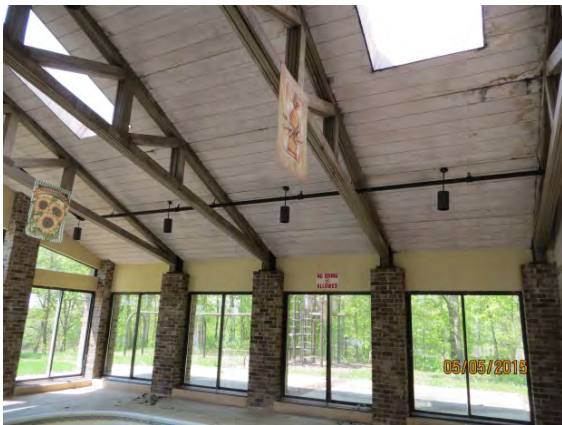
Figure 35 – Indoor swimming pool – pendant incandescent fixtures

Figure 36 – Indoor swimming pool – pendant incandescent fixtures

Figure 37 – Indoor swimming pool – pendant incandescent lighting fixtures

Figure 38 – Indoor swimming pool – pendant incandescent lighting fixtures

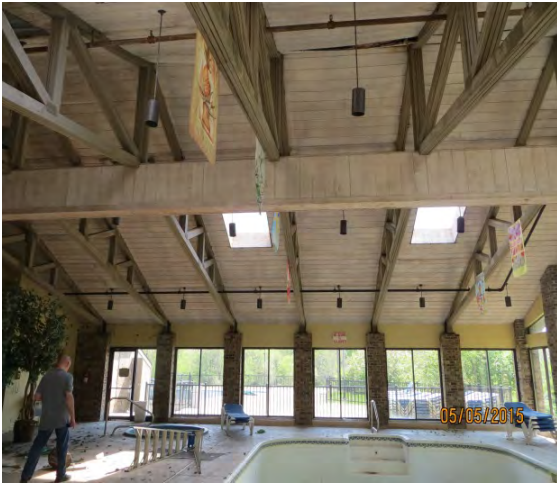
Figure 39 – Pendant incandescent lighting fixtures

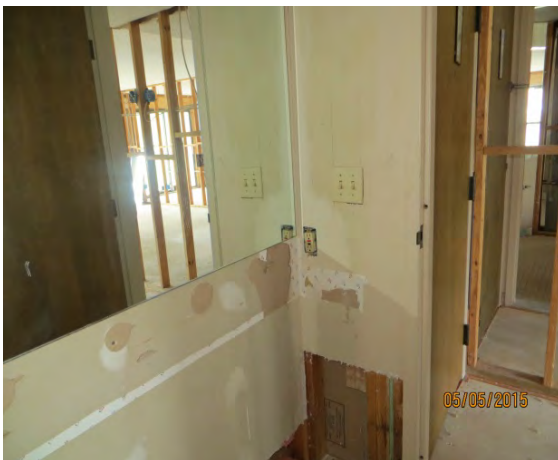
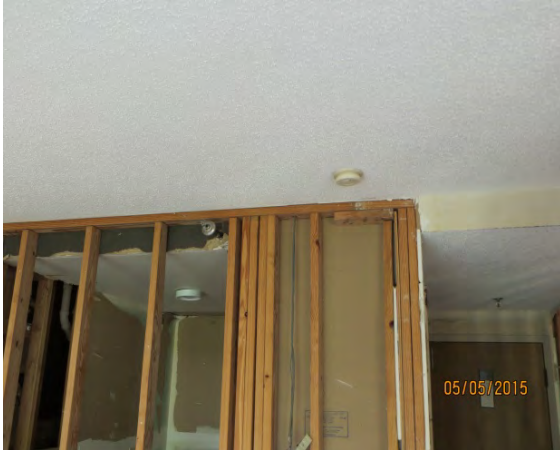
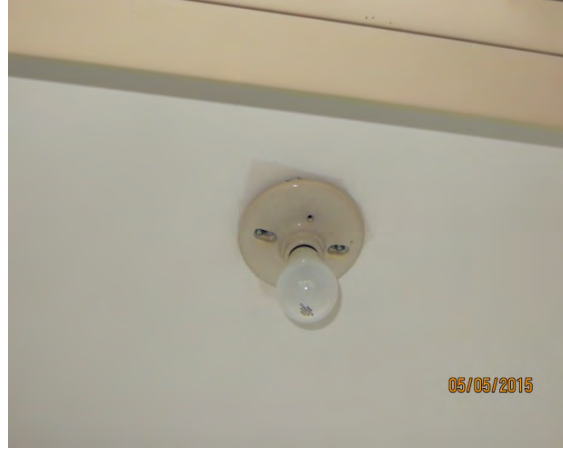
Existing outlets and wall switches in the guestrooms have been left installed in their outlet boxes. If the drywall has been removed then the individual device cover plate has also been removed. The existing non-metallic sheathed cables run from outlet box to outlet box through the wall studs and back to a local panelboard. Continuity and high-pot testing of the cable would be required to determine condition of the cables and if circuits have been maintained. New code requirements for outlets will necessitate their replacement (Figures 41 through 49)

Figure 41 - Typical open wall for every hotel room – electrical outlets with non-metallic sheathed cable installation

Figure 42 - Typical open wall for every hotel room – electrical outlets with non-metallic sheathed cable installation

Figure 43 - Typical Open Wall

Figure 44 - Typical Suite Foyer

Figure 45 - Typical Bathroom Wall

Figure 46 - Typical Bathroom Ceiling

Figure 47 - Typical Ceiling Mounted Smoke Detector

Figure 48 - Typical Suite Closet Light

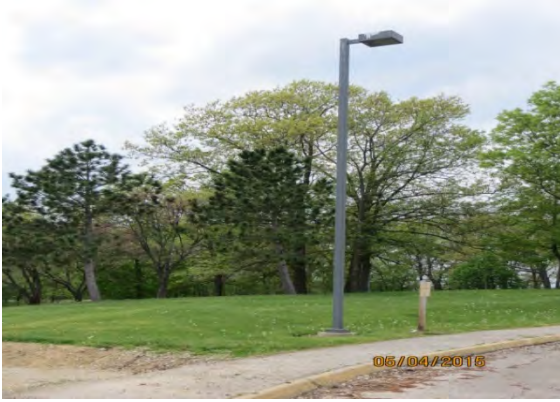
**Parking Lots:** The North, East and West parking lot lights consist of 30' high poles with rectangular type light fixtures and HID lamps. There is some evidence of rusting along the base of some of the poles (Figure 51).

Figure 51 - Typical 30'-0" Pole Lighting

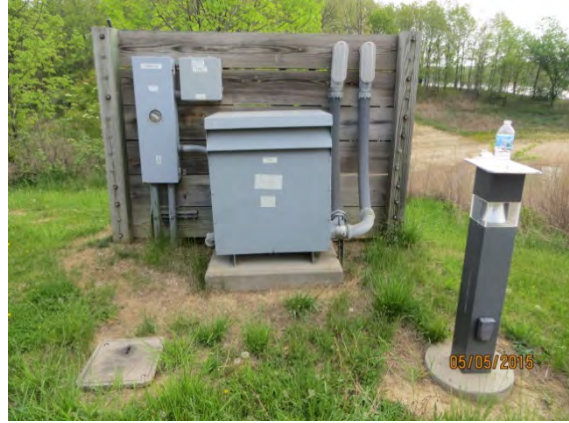
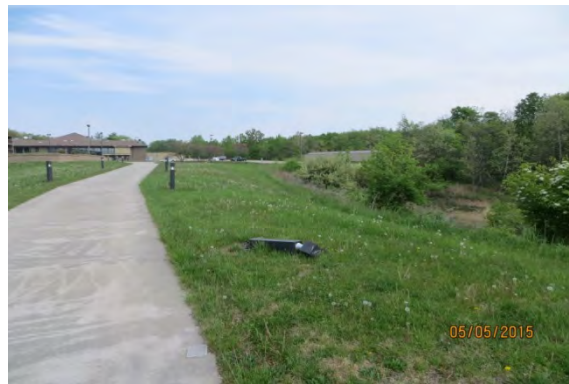
The pathway leading to the boat dock area consists of square bollards and 10' high light poles with rectangular type fixtures and HID lamps. Three existing bollards have been pulled out of the ground (Figures 52, 53 and 54).

Figure 52 - Typical Square Bollard Fixture

Figure 54 - Bollard Fixture Rooted-up

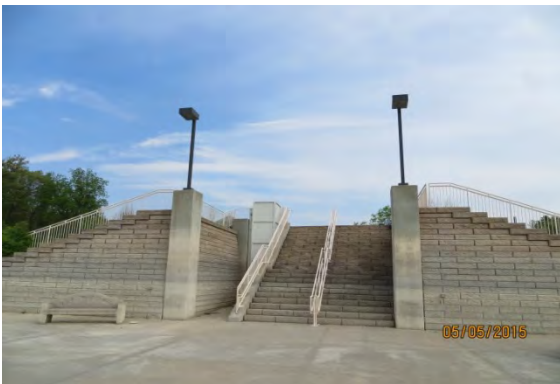
Figure 55 - Typical Boat Dock Lighting

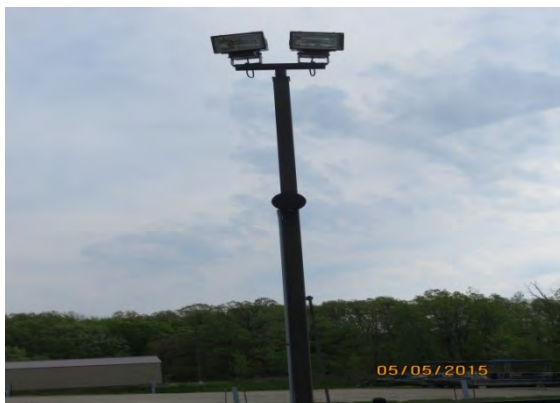
The Outdoor Swimming Pool lighting fixtures consisting of 30' high light poles with two fixtures and HID lamps. There is also a speaker mounted in the middle of the lighting poles (Figure 55).

Figure 55 - Typical Outdoor Swimming Pool Flood Light HID Fixtures  
Building perimeter wall mounted fixtures need to be replaced (Figures 57 and 58).

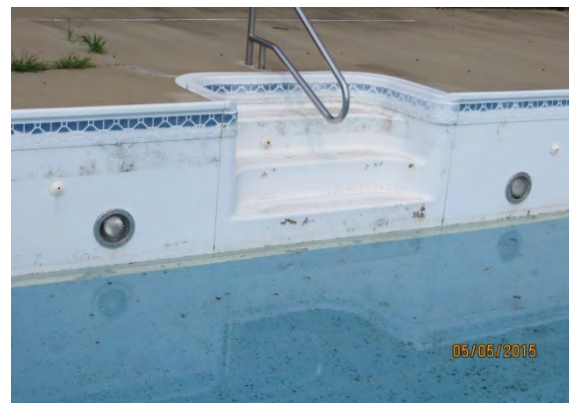
Figure 56 - Swimming Pool – Recessed with Gasket Fixture
