# EAGLE CREEK RESORT ASSESSMENT

## ILLINOIS DEPARTMENT OF NATURAL RESOURCES

DNR PROJECT 3-15-006

May 9, 2016

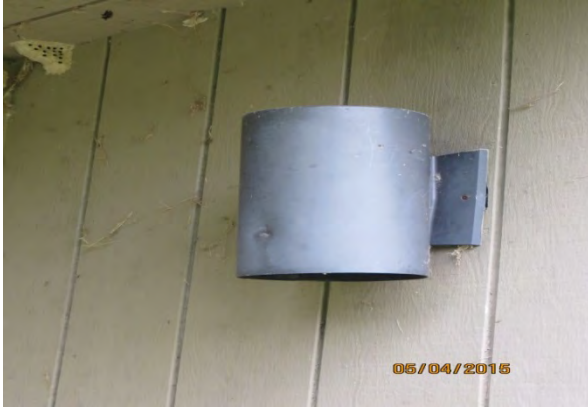
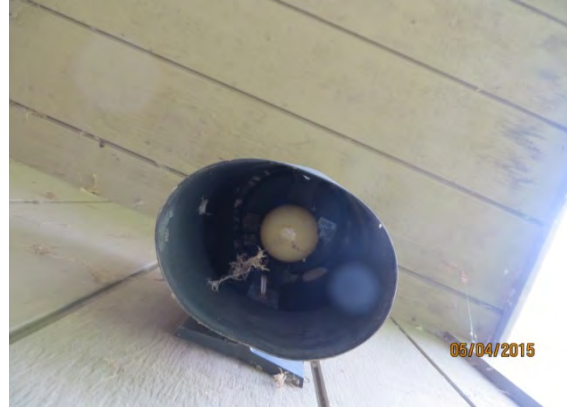
Figure 57 - Building Perimeter Incandescent Wall Sconces

Figure 58 - Building Perimeter Incandescent Wall Sconces

Figure 55 - Typical Outdoor Swimming Pool Flood Light HID Fixtures  
Building perimeter wall mounted fixtures need to be replaced (Figures 57 and 58).

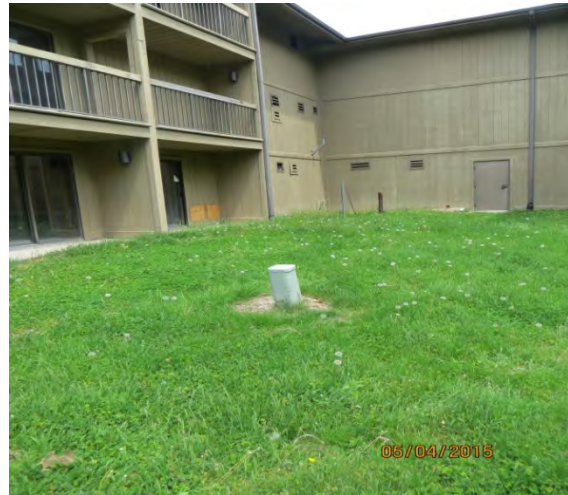
The existing incoming telephone service is fed from the telephone outdoor HUB (Figure 59). An ISO 25/125 telephone cable runs in the ceiling and loops down to the Telephone Equipment Enclosure located in the Equipment Room (Room P1-23) adjacent to the Main Lobby.

Figure 59 - Existing Telephone Service

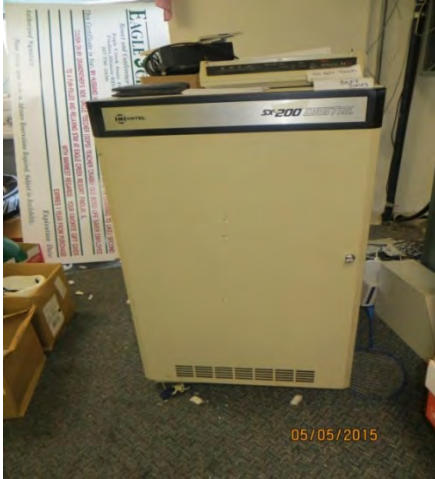
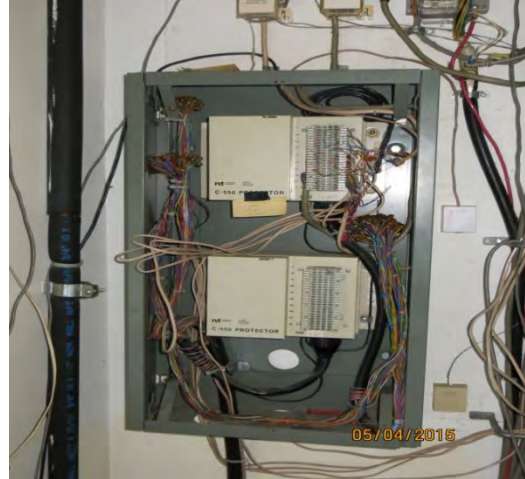
- Nextel SX 200 digital telephone switch (Figure 60),
- Hub enclosure (Figure 61),
- A rack mounted patch panel,
- Branch wiring is distributed above the drop ceiling to the individual guestrooms in Building Wings "A" & "B" and to the rest are for miscellaneous rooms requiring telephone service.
- The existing telephone jacks and cover plates have been removed from all the guestrooms. The individual telephone wires are coiled in their respective outlet boxes (Figures 63 and 64).

Figure 60 - Existing Main Telephone Server (SX 200 Digital)

Figure 61 - Existing Telephone Hub Panel

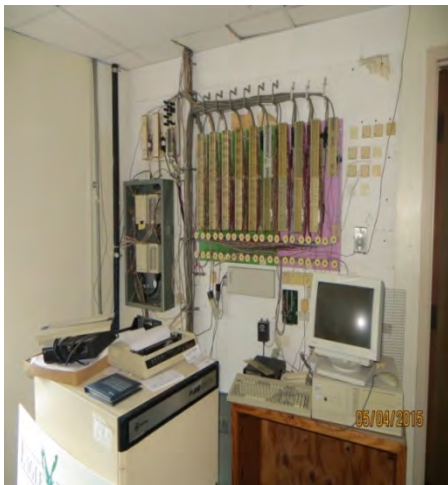
Figure 62 - Existing Main Telephone Distribution System

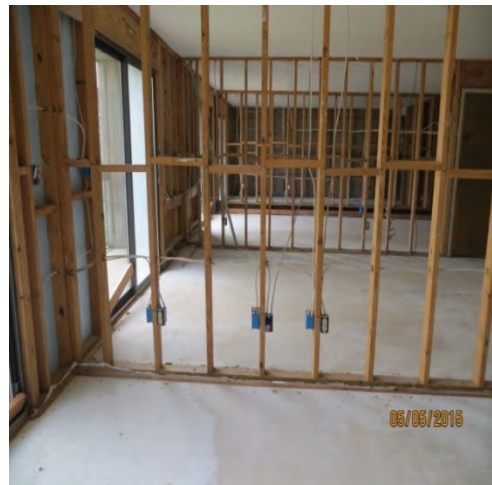
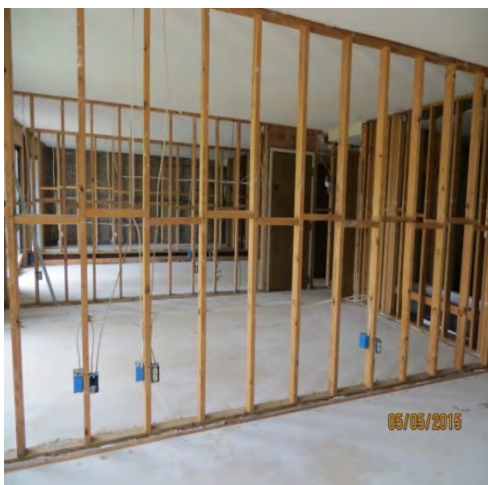
Figure 63 - Typical Guestroom with Back-to-Back Telephone Outlets with Coiled Telephone Wires

Figure 64 - Typical Guestroom with Back-to-Back Telephone Outlets with Coiled Telephone Wires

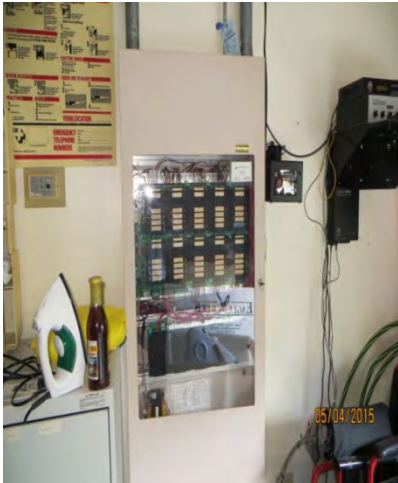
The existing Fire Alarm System is non-addressable analog type. The existing Fire Alarm Panel is located in the Equipment Room (Room P1-23) adjacent to the Main Lobby (Figure 65). The individual fire alarm devices are connected to the fire alarm panel via cables, which are not run in conduit. The individual fire alarm devices are mounted throughout the facility as described below.

Figure 65 - Existing Main Fire Alarm Panel

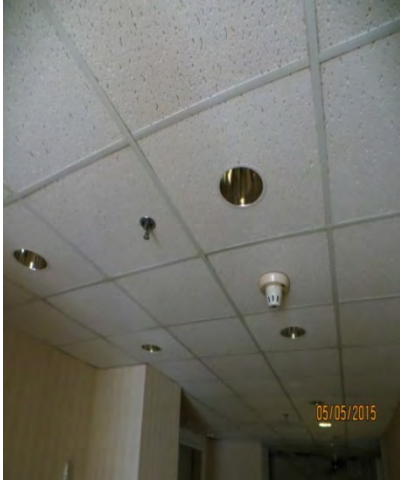
Figure 67 - Existing Smoke Detector Adjacent To Elevator Lobby

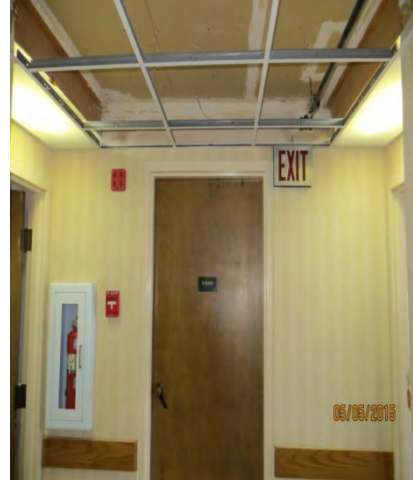
The pull station with audio alarms is installed at exit locations (Figure 68).

Figure 68 - Existing Manual Pull Station

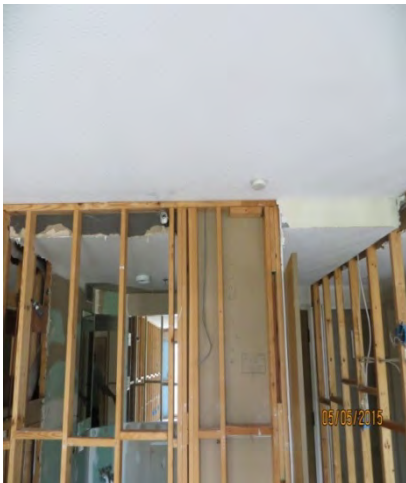
In the guestrooms the smoke detectors are mounted in ceiling and visual enunciators are mounted on the walls (Figures 69 and 70).

Based on the fact that the system has been abandoned and demolition work has been completed without properly protecting devices, there is a high likelihood that devices will not perform to manufacturers specifications. In addition, a new code compliant system will be required.

Figure 69 - Typical Smoke Detector in Guestroom

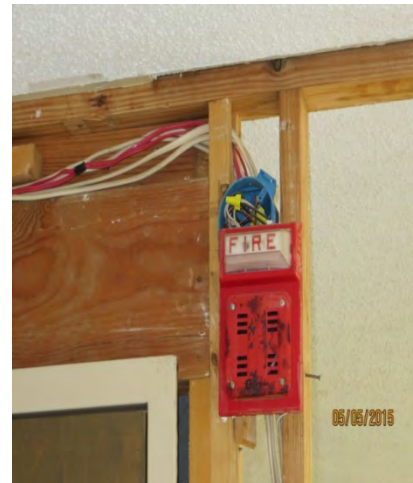
Figure 70 - Typical Audio Visual Alarm

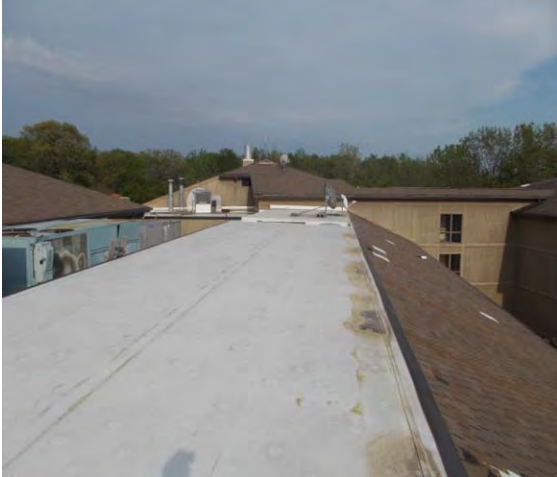
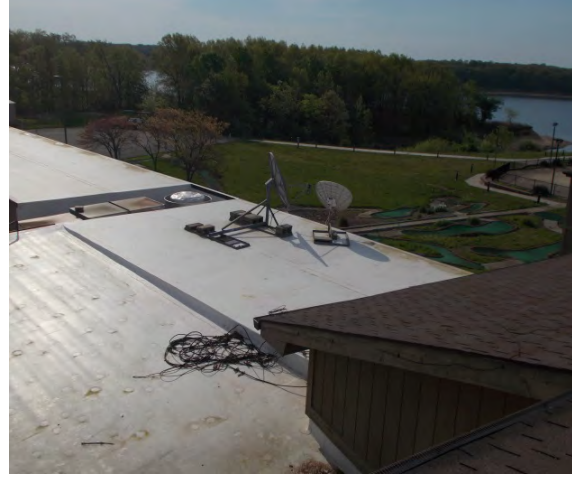
The existing TV System consists of two existing satellite dishes mounted in the roof on Building Wing "A" and Building Wing "B" (Figures 71 and 72). Coax cables are pulled from the top floors down to the ground floors creating a riser system. Typically, a maximum of 6 guestrooms are connected to a single riser cable via a series of splitters. The satellite system electronics could not be located and it is assumed they have been sent back to the satellite service provider.

Figure 71 - Existing Cable TV Dish Antennae

Figure 72- Existing Cable TV Dish Antennae

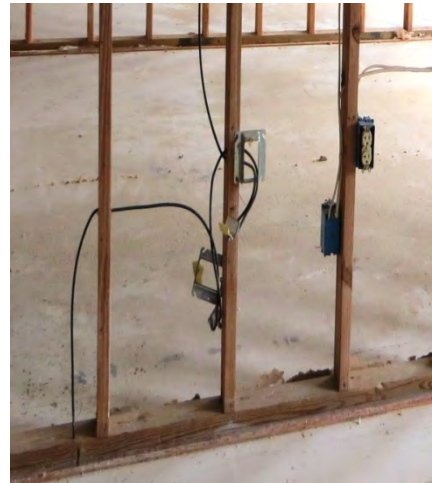
The individual coax cables are pulled to drywall mud rings located in the guestrooms where the cables are connected to a splitter and a coax cable connector. The individual device covers have been removed from the mud ring and the cables and splitters have been left dangling (Figures 73 and 74).

Figure 73 - Typical Existing Cable and TV Outlets Location in Guestrooms

Figure 74 - Typical Existing Cable and TV Outlets Location in Guestrooms

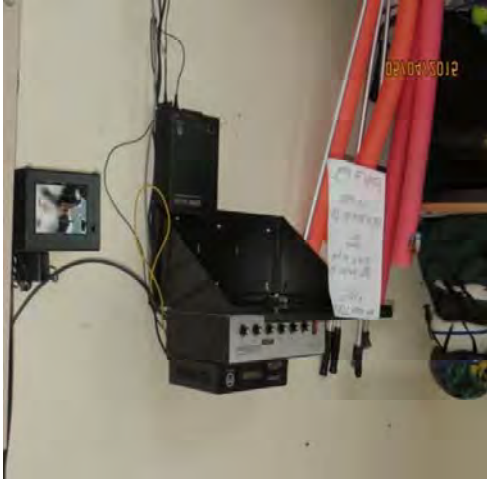
- The existing head-end equipment is located in the Equipment Room (Room P1-23) adjacent to the Main Lobby (Figure 75).
- Interior sound system speaker are located in the corridor lobby elevator, game room, meeting rooms, and banquet room (Figures 76 through 79).
- Exterior sound system speakers are located in the swimming pool area (in perimeter wall and light pole mounted in the middle – Figures 80 through 82).

It appears the system was installed as part of the the original construction and has reached its useful life.

Figure 75 - Existing Main PA System

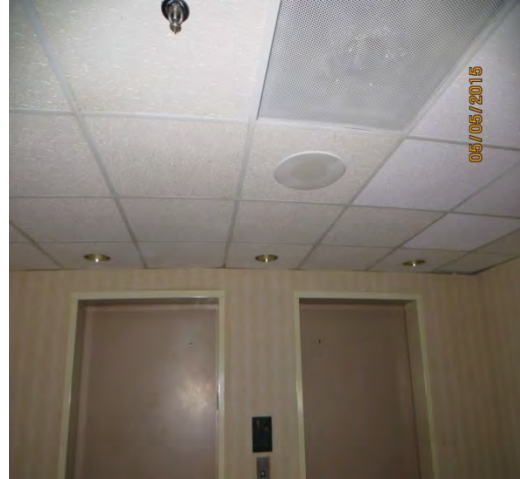
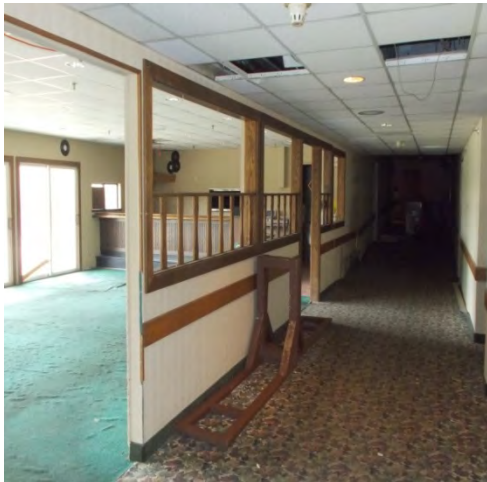
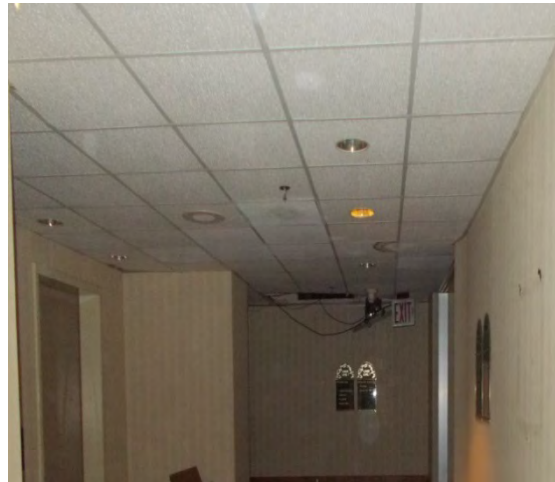
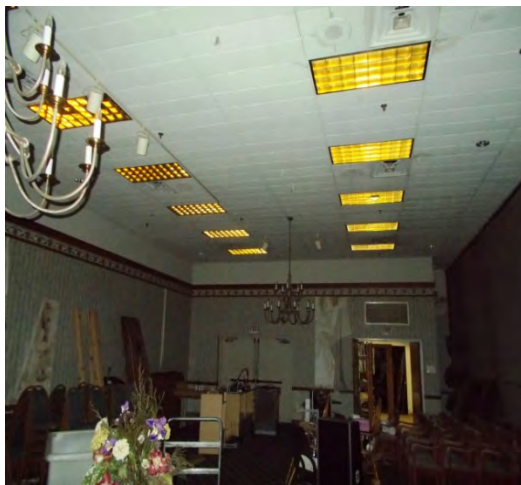
Figure 76 - Existing PA Speaker – Lobby

Figure 77 - Existing PA Speaker - Corridor

Figure 78 - Existing PA Speaker - Corridor

Figure 79 - Existing PA Speaker – Restaurant

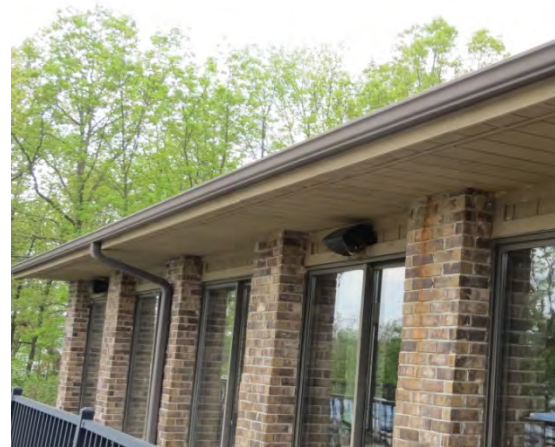
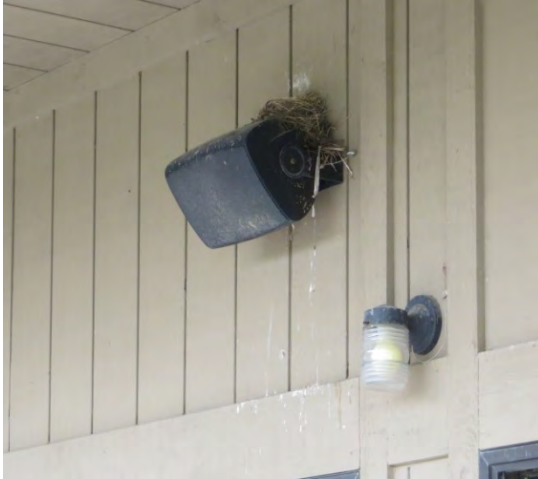
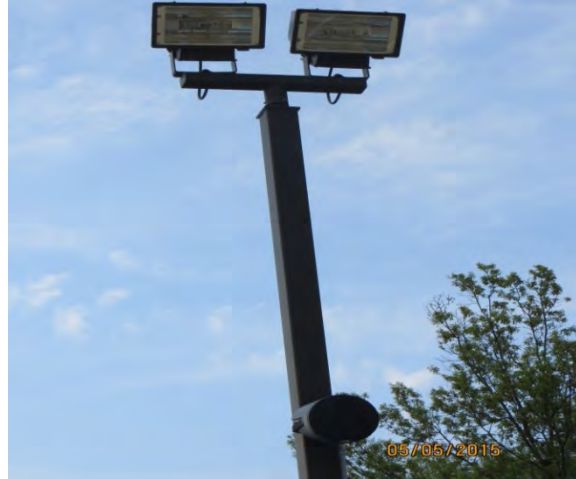
Figure 80 - Existing PA Speaker – Perimeter

Figure 81 - Existing PA Speaker –  
Outdoor Swimming Pool Area

Figure 82 - Existing PA Speaker –  
Outdoor Swimming Pool Area

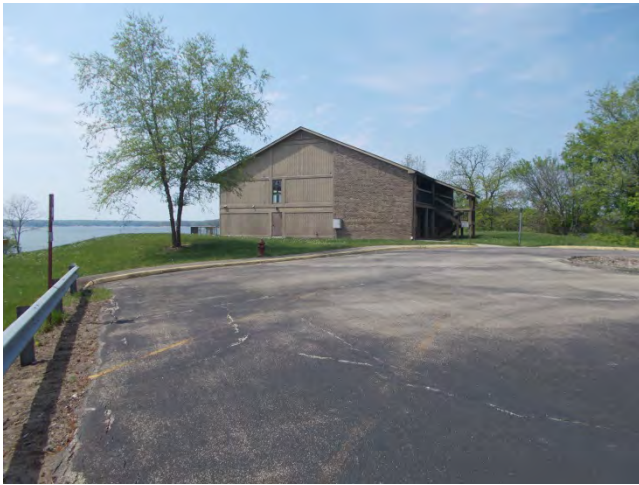
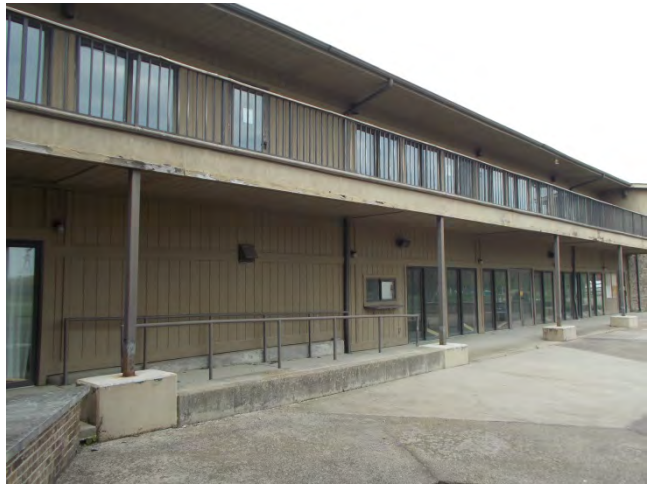
Separate Eagle's Landing hotel building has no accessible parking spaces.

The accessible route leading from the hotel site to the pool and mini-golf areas and various off-site amenities appear to have proper slopes and widths per code. There are no observed detectable warnings along any part of the accessible route where pedestrian walks intersect with vehicular traffic. Where accessible routes exceed maximum slope requirements a handrail has been installed. However, handrails must be upgraded per current code requirements (handrails must have straight 12 inch extensions at top and bottom of ramp).

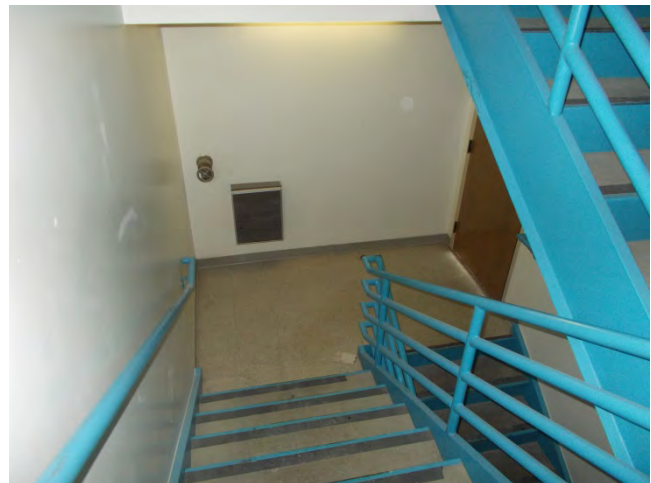
Typical Interior Stair

The stairwells typically meet riser and tread size requirements and have proper handrail configurations on each side of stair stringers. However, areas of rescue assistance are not provided at floors that do not exit to grade.

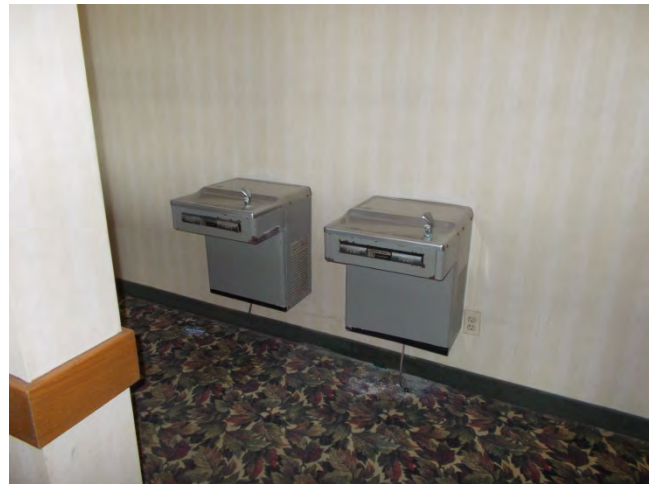
Drinking Fountains

Drinking fountains are provided only at the lower floor adjacent to the restroom entrance. Drinking fountains formerly located outside the first floor restrooms have been removed. Where drinking fountains are present they are both installed at the same height (ADA height), no drinking fountain is installed at the proper height for a standing person.
